### **TOTAL LOSS REPORT**

**RE: Road traffic Accident: Mr Nirvail Singh Kang: 10/05/2025**

### **DESKTOP ASSESSMENT**

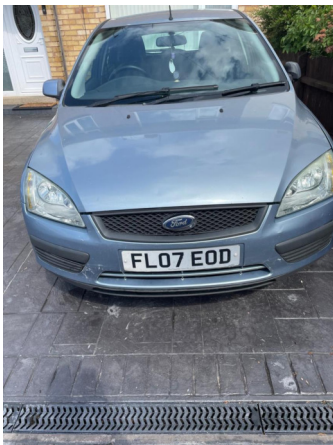
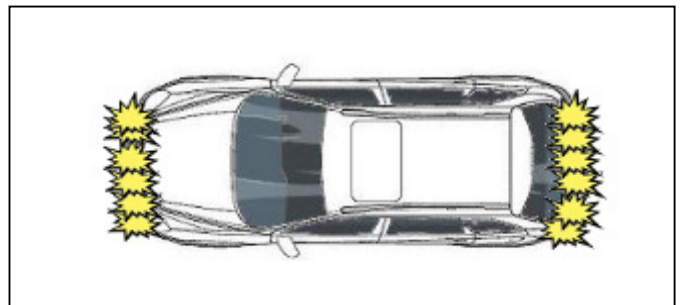
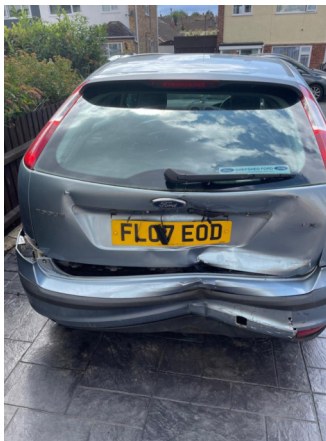
Impact Area

The vehicle has suffered moderate to heavy collision/impact damage to the rear, and light to moderate collision/impact to the front.

09/07/2025 - Please note the vehicle is unroadworthy as the rear body has been compromised.

This vehicle is damaged beyond any form of economical repair, therefore in our Engineers professional opinion it should not be returned to the road and a certificate of destruction should be completed / issued We suggest that the sale of the salvage will realise in the order of £17.82. **We have not taken any action towards removal of the salvage at this time.**
