### **TOTAL LOSS REPORT**

**RE: Road traffic Accident: Mr Mohammad Aman: 28/06/2025**

| Make | <b>MITSUBISHI</b> | Registration | <b>KE65XTX</b> |
| Model | <b>OUTLANDER GX 3H +</b> | Status | <b>T/Loss</b> |

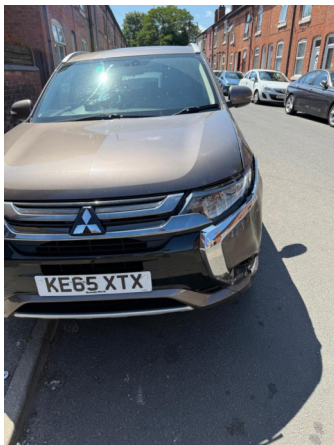
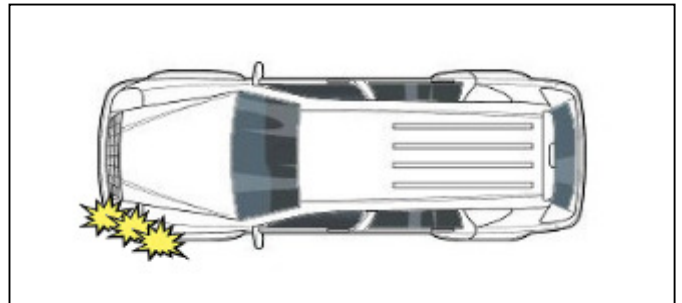
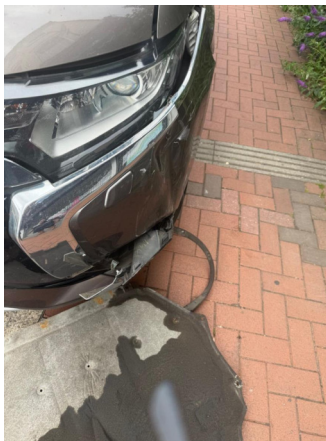
Impact Area

The vehicle has suffered moderate to heavy collision/impact damage to the left hand front.

01/07/2025 - Please note the vehicle is unroadworthy due to the extent of panel distortion sustained to the nearside front.
