### **REPAIRABLE REPORT**

**RE: Road traffic Accident: Stewart Blackburn: 12/08/2022**

| Make | <b>FORD</b> | Registration | <b>EU63OZA</b> |
| Model | <b>S-MAX TITANIUM TDC</b> | Status | <b>Repair</b> |

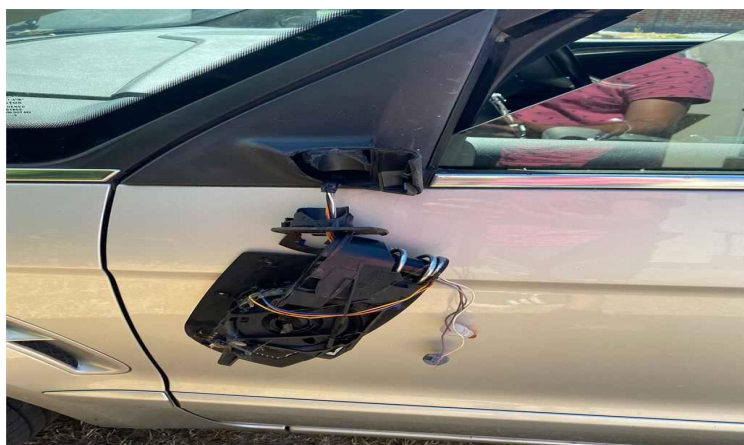
Impact Area

The vehicle has suffered light to moderate collision/impact damage to the left hand side.

24/08/2022 - Please note the vehicle is unroadworthy due to the broken/insecure mirror.
