### **CONTRACT REPAIR REPORT**

**RE: Road traffic Accident: Dr Sarah Daley: 20/07/2022**

| Make | <b>VOLKSWAGEN</b> | Registration | <b>GD08ARZ</b> |
| Model | <b>EOS SPORT T FSI</b> | Status | <b>Repair</b> |

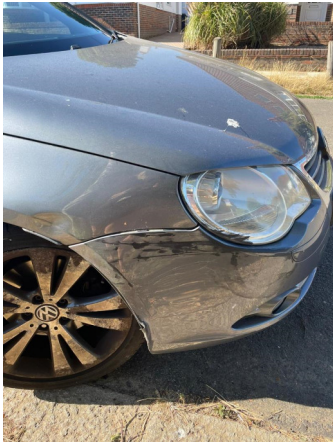
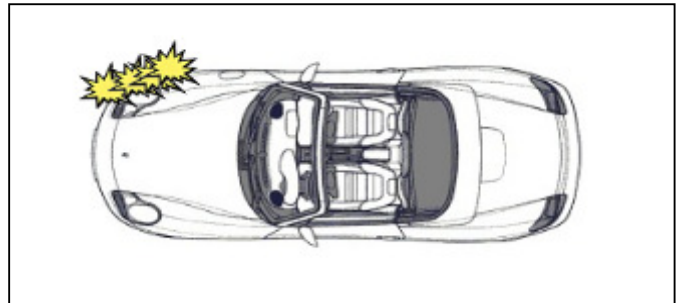
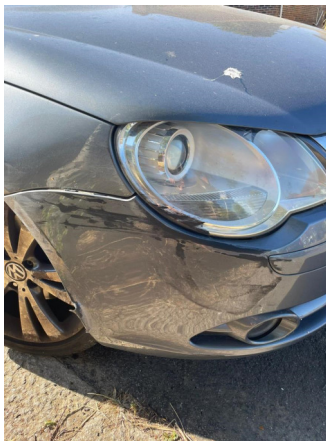
Impact Area

The vehicle has suffered moderate collision/impact damage to the right hand front.

24/08/2022 - Vehicle is unroadworthy due to the damaged/insecure front bumper.

Main new parts required

Front Bumper  
Front Bumper Beam

Os Headlamp  
Sundries/clips/fixings
