### **REPAIRABLE REPORT**

**RE: Road traffic Accident: Jeffery Clayton: 07/08/2022**

| Make | <b>MERCEDES-BENZ</b> | Registration | <b>J77EVR</b> |
| Model | <b>C250 AMG LINE PREM</b> | Status | <b>Repair</b> |

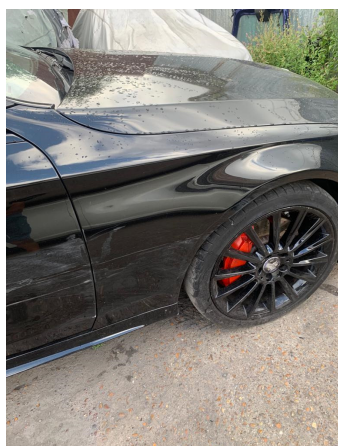
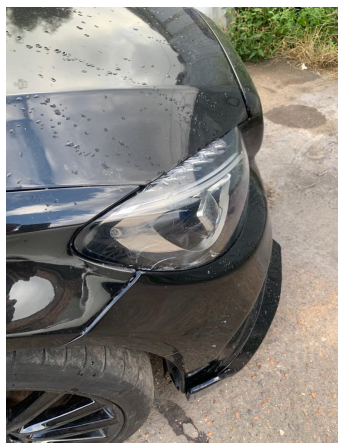
Impact Area

The vehicle has suffered moderate collision/impact damage to the right hand side.

23/08/2022 - Please note the vehicle is unroadworthy due to the broken offside mirror and steering fault.
