### **REPAIRABLE REPORT**

**RE: Road traffic Accident: James Robinson: 20/08/2022**

| Make | <b>VAUXHALL</b> | Registration | <b>KY63GVC</b> |
| Model | <b>INSIGNIA DESIGN CD</b> | Status | <b>Repair</b> |

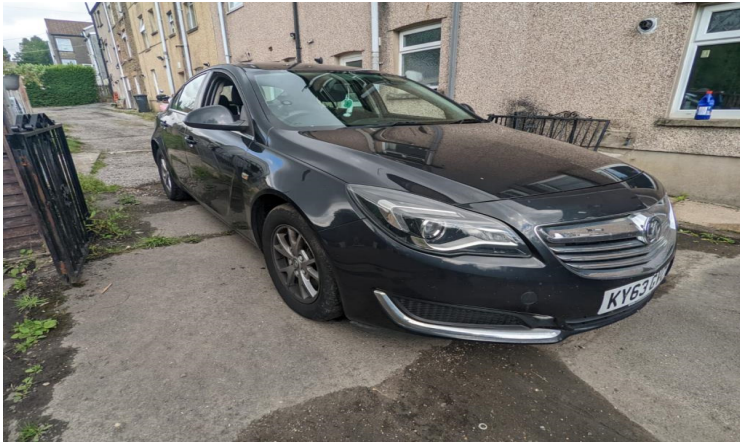
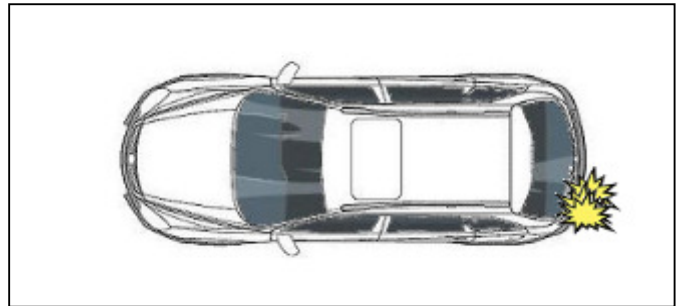
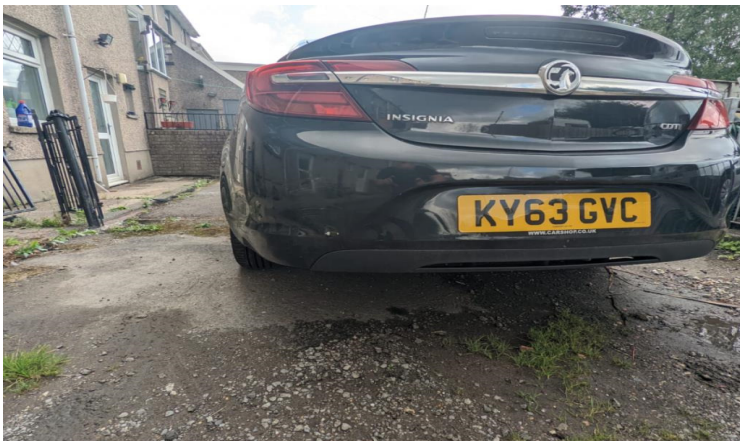
Impact Area

The vehicle has suffered light to moderate collision/impact damage to the left hand rear.
