**CONTRACT REPAIR REPORT**

**RE: Road traffic Accident: Mr David Guildford: 01/06/2024**

| Make | JAGUAR | Registration | S500MSK |
| Model | XJ PORTFOLIO V8 AUT | Status | Repair |

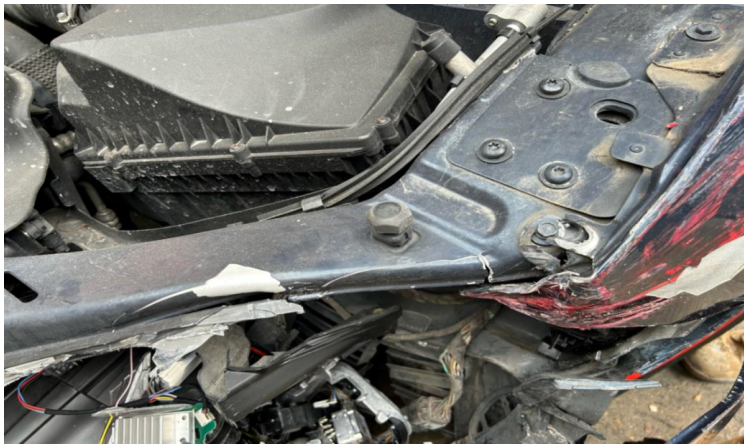
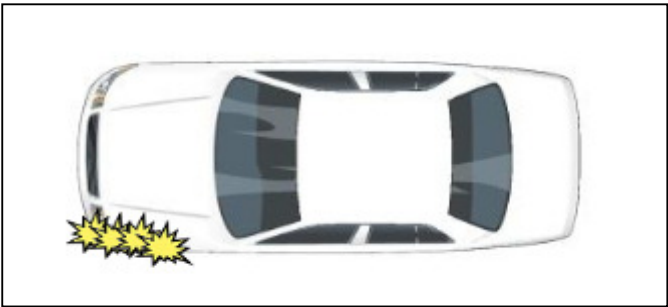
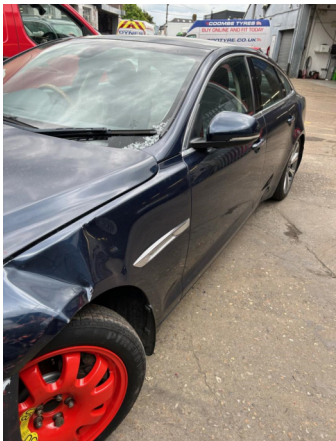
Impact Area

The vehicle has suffered moderate collision/impact damage to the left hand front.

28/06/2024 - Please note the vehicle is unroadworthy due to the extent of panel distortion sustained to the nearside front.

To ensure no further repair costs are found we have agreed a contract repair figure with the repairers in the sum total of £7,798.91 which is inclusive of VAT but subject to the deduction of any applicable excess.
