26-1837802/2428035

# Total Loss Damage Assessment Report

| Model | Civic I-dtec Sr |
| Registration | OY15SXW |

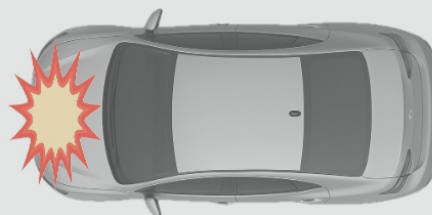
**Impact Diagram**

| Impact Magnitude | Moderate |

Loose Insecure and Sharp Components

| Front Bumper Lining | Front Bumper Cover | Front Bumper Reinforcement |
| Front Bumper Side Support (nearside) | Front Bumper Side Support (offside) | Front Bumper Brace (nearside) |
| Front Bumper Brace (offside) | Headlamp, Complete (with Indicator) (nearside) | Headlamp, Complete (with Indicator) (offside) |
| Front Grille Cover | Sundry Items (2.00%) | |

Having examined the damage as presented, we have estimated repair times and methods, which are detailed below. We would recommend the vehicle to be dealt with on a total loss basis. The damage sustained to the vehicle would render the salvage as category 'N' (non structural damage) in accordance with the [Salvage Code Of Practice](#).
