### **TOTAL LOSS REPORT**

**RE: Road traffic Accident: John Brown-Hicks : 08/08/2025**

| Make | <b>VOLKSWAGEN</b> | Registration | <b>CE59GXP</b> |
| Model | <b>TOURAN SE TDI 105</b> | Status | <b>T/Loss</b> |

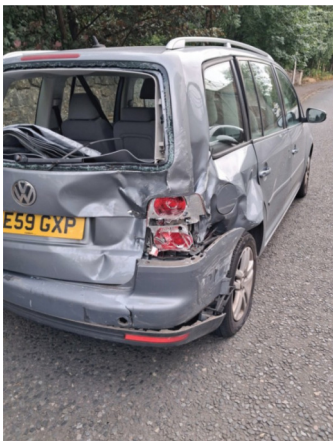
The vehicle has suffered moderate collision/impact damage to the right hand rear.

19/08/2025 - Please note the vehicle is unroadworthy due to the extent of panel distortion sustained to the offside rear.

This vehicle is damaged beyond any form of economical repair, therefore in our Engineers professional opinion it should not be returned to the road and a certificate of destruction should be completed / issued We suggest that the sale of the salvage will realise in the order of £50.00. **We have not taken any action towards removal of the salvage at this time.**
