**Our Ref:** ap.qdos261189

### **TOTAL LOSS REPORT**

**RE: Road traffic Accident: Ann Ware: 29/04/2026**

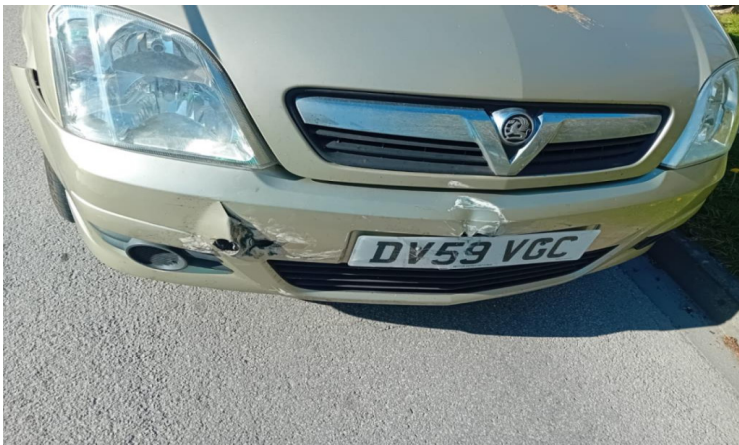
Impact Area

The vehicle has suffered moderate collision/impact damage to the front.

Please note the vehicle is unroadworthy due to the extent of panel distortion sustained to the front end.
