### **TOTAL LOSS REPORT**

**RE: Road traffic Accident: James McNeil: 18/08/2022**

| Make | <b>VOLKSWAGEN</b> | Registration | <b>H8JTM</b> |
| Model | <b>GOLF GTD</b> | Status | <b>T/Loss</b> |

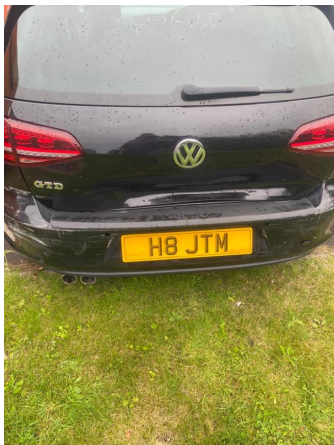
Impact Area

The vehicle has suffered moderate to heavy collision/impact damage to the rear.

24/08/2022 - Please note the vehicle is unroadworthy as the rear body has been compromised.
