### **TOTAL LOSS REPORT**

**RE: Road traffic Accident: Mr Neil Hanna: 05/04/2026**

**Our Ref:** ap.qdos26931

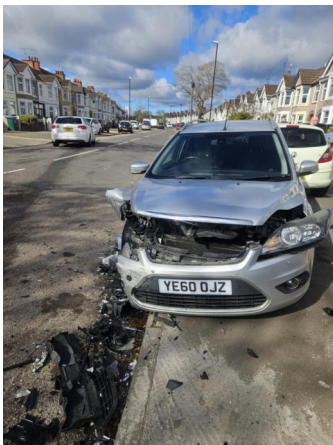
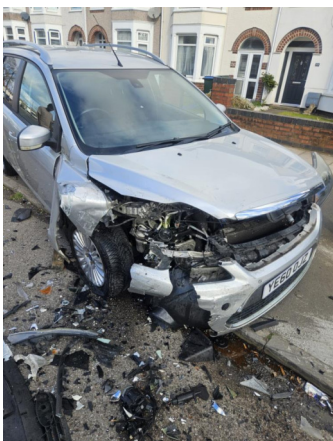
The vehicle has suffered heavy collision/impact damage to the right hand front.

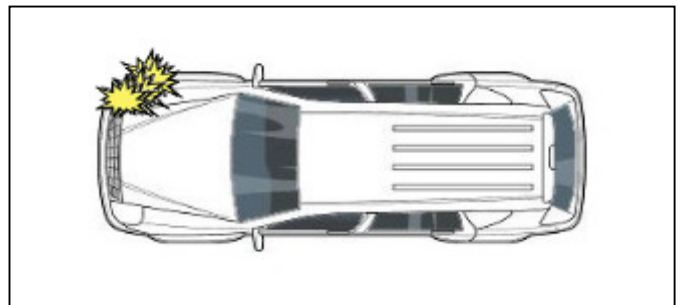
Impact Area

Please note the vehicle is unroadworthy due to the extent of panel distortion sustained to the offside front.
