### **TOTAL LOSS REPORT**

**RE: Road traffic Accident: Mr Damian Zgoda: 20/05/2026**

| Make | <b>BMW</b> | Registration | <b>YG57Y00</b> |
| Model | <b>118D SE</b> | Status | <b>T/Loss</b> |

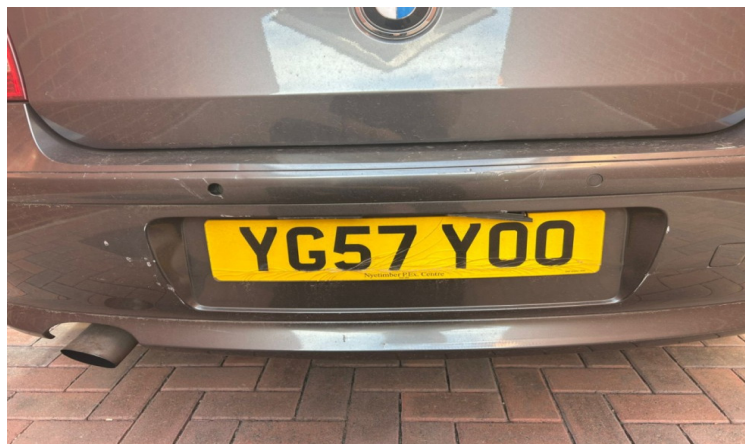
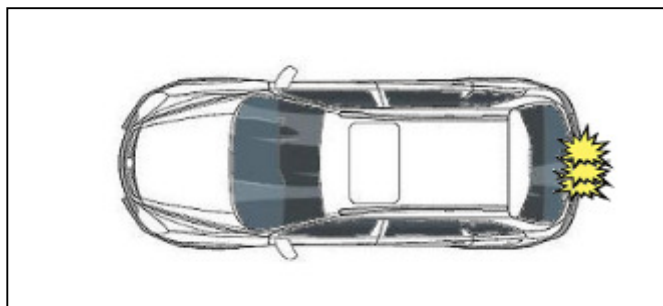
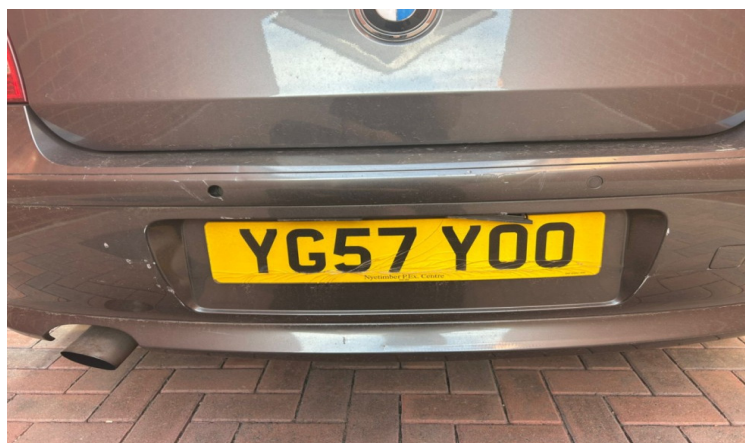
Impact Area

The vehicle has suffered light to moderate collision/impact damage to the rear.

we suggest that the rear number plate lamp is secured properly before the vehicle returns to use.
