## To the Court REPAIRABLE REPORT

| Vehicle: <b>BMW 420D M SPORT</b> | | Colour: <b>Red</b> | Speedo: <input type="text"/> | Miles: <input type="text"/> |
| Reg No: <b>DF18FEJ</b> | Registered: <b>May 2018</b> | Type: <b>Coupe</b> | Trans: <b>Manual</b> | |
| Damage: <b>Very Light Collision/Impact Front Bumper</b> | Incident: <b>10/08/2026</b> | L/H/F Tyre <b>Not Kno</b> | L/H/R Tyre <b>Not Kno</b> | |

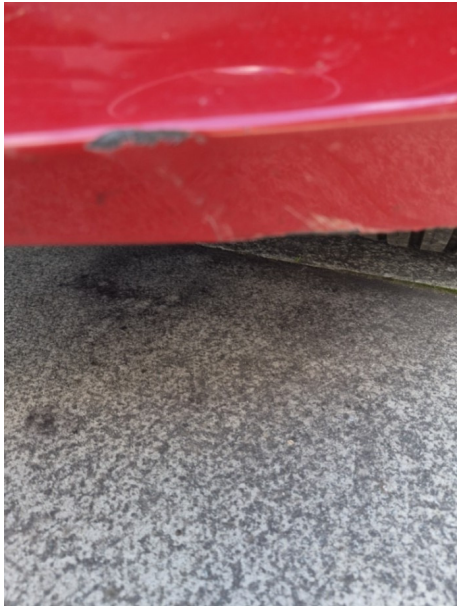
CLvehicedamage3jpg-V1.jpg

The vehicle has suffered very light collision/impact damage to the front bumper.
