### REPAIRABLE REPORT

**RE: Road traffic Accident: Mike Jones: 03/06/2025**

| Make | <b>CITROEN</b> | Registration | <b>BX17KKB</b> |
| Model | <b>RELAY 40 H-Y L4H2 EP</b> | Status | <b>Repair</b> |

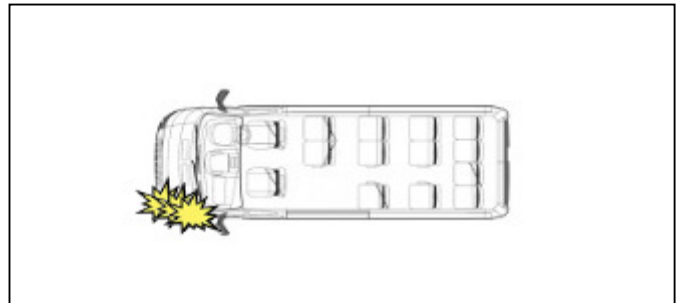
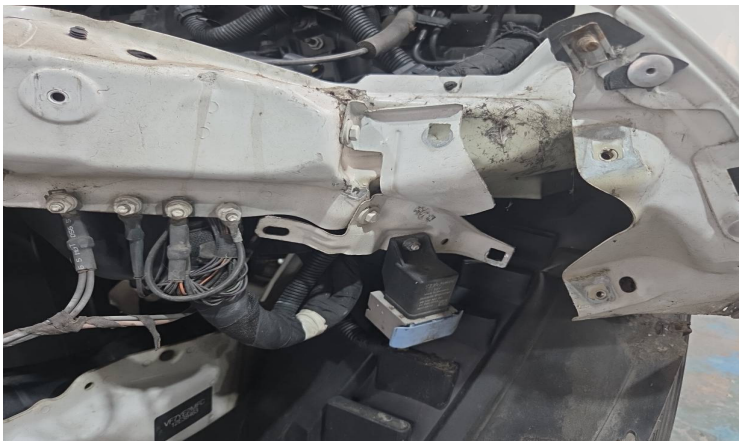
Impact Area

The minibus has suffered moderate collision/impact damage to the left hand front.
