## To the Court REPAIRABLE REPORT

| Vehicle: <b>BMW 435I M SPORT AUTO</b> | | Colour: <b>BLACK</b> | Speedo: <span style="border: 1px solid black; padding: 2px;"> </span> <b>Miles</b> | |
| Reg No: <b>OY64BTE</b> | Registered: <b>Sep 2014</b> | Type: <b>Convertible</b> | Trans: <b>Automatic</b> | |
| Damage: <b>Light to Moderate Collision/Impact Rear</b> | | Incident: <b>17/05/2026</b> | | |

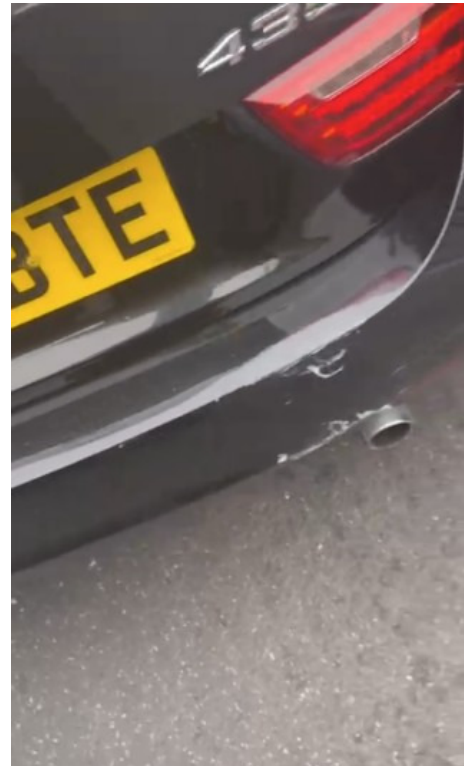
2\_CLVdamage45430png-V1.png

The vehicle has suffered light to moderate collision/impact damage to the rear.

**New parts required:-**Rear Bumper Cover, Rear Bumper Support, Rr Ctr Bumper Guide, Lwr Rr Bumper Cover, Car Care Kit, Glass Lifting Tape, Sundry Parts
