## To the Court REPAIRABLE REPORT

| Vehicle: <b>HONDA JAZZ HS-T IMA CVT</b> | | Colour: <b>Blue</b> | Speedo: <input type="text"/> | Miles <input type="text"/> |
| Reg No: <b>KE13XRT</b> | Registered: <b>Jan 2025</b> | Type: <b>5 Door Hatchback</b> | Trans: <b>CVT</b> | |
| Damage: <b>Light Collision/Impact LH Front</b> | Incident: <b>12/04/2026</b> | L/H/F Tyre <b>Not Kno</b> | L/H/R Tyre <b>Not Kno</b> | |

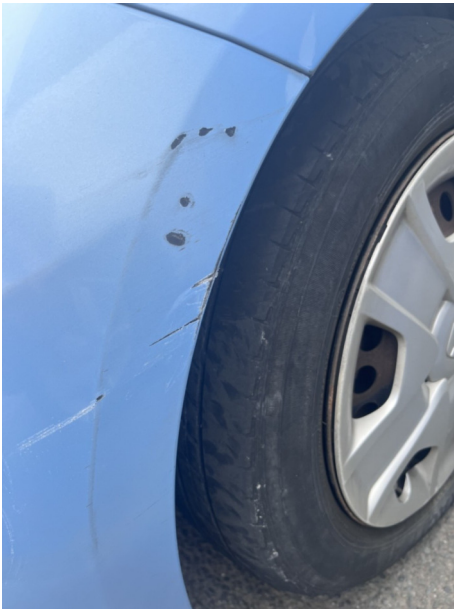
ClientFrontWheelArchDamages3-V1.jpeg

The vehicle has suffered light collision/impact damage to the left hand front.
