## To the Court REPAIRABLE REPORT

| Vehicle: <b>VOLKSWAGEN GOLF GTD S-A</b> | Colour: <b>WHITE</b> | Speedo: <b>87000</b> | Miles |
| Reg No: <b>T88SSO</b> | Registered: <b>Mar 2014</b> | Type: <b>5 Door Hatchback</b> | Trans: <b>Semi-Auto</b> |

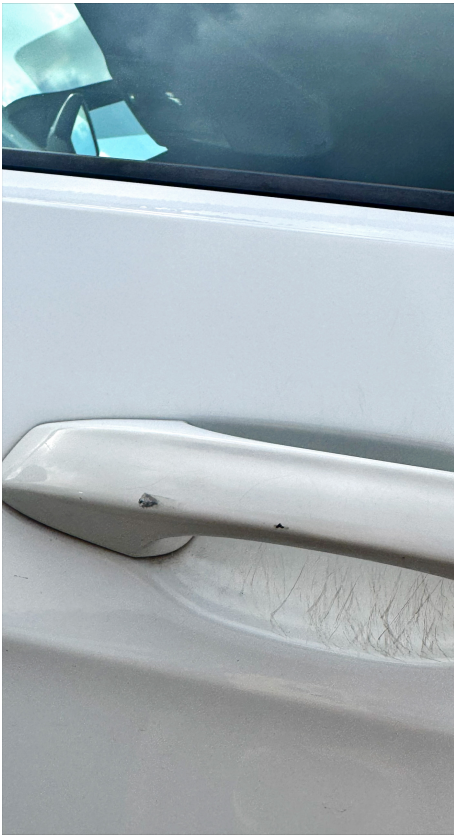
clv damage 1.jpeg

The vehicle has suffered light to moderate collision/impact damage to the left hand side.

**New parts required:-**L/F Door Out Handle, Sundry Parts
