### REPAIRABLE REPORT

**RE: Road traffic Accident: Shirley Osowiecki: 16/07/2022**

| Make | <b>KIA</b> | Registration | <b>DX71UUT</b> |
| Model | <b>NIRO 3 HEV S-A</b> | Status | <b>Repair</b> |

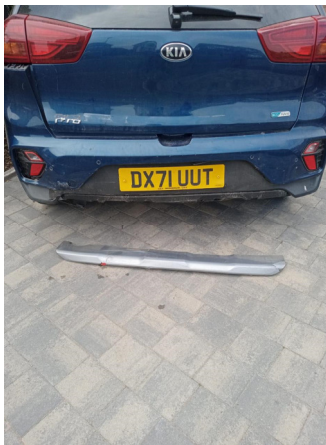
Impact Area

The vehicle has suffered moderate to heavy collision/impact damage to the rear.
