### REPAIRABLE REPORT

**RE: Road traffic Accident: Jeffery Clayton: 07/08/2022**

| Make | <b>MERCEDES-BENZ</b> | Registration | <b>J77EVR</b> |
| Model | <b>C250 AMG LINE PREM</b> | Status | <b>Repair</b> |

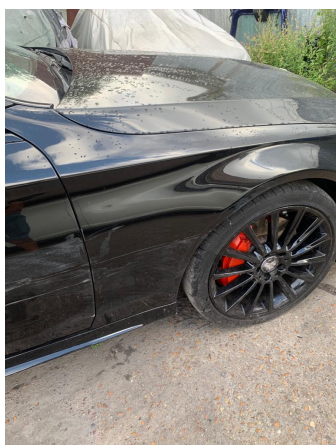
Impact Area

The vehicle has suffered moderate collision/impact damage to the right hand side.

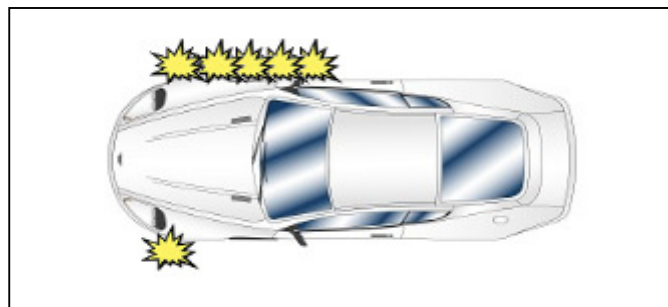
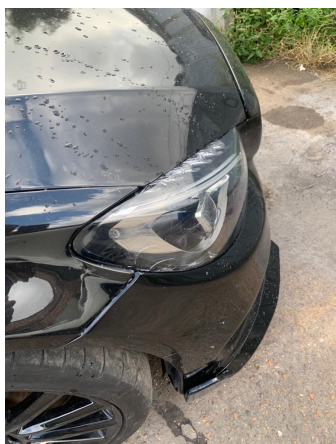
23/08/2022 - Please note the vehicle is unroadworthy due to the broken offside mirror and steering fault.
