### **TOTAL LOSS REPORT**

**RE: Road traffic Accident: Nigel Toms: 15/04/2026**

| Make | <b>LAND ROVER</b> | Registration | <b>AK09VRY</b> |
| Model | <b>RANGE ROVER SP HSE</b> | Status | <b>T/Loss</b> |

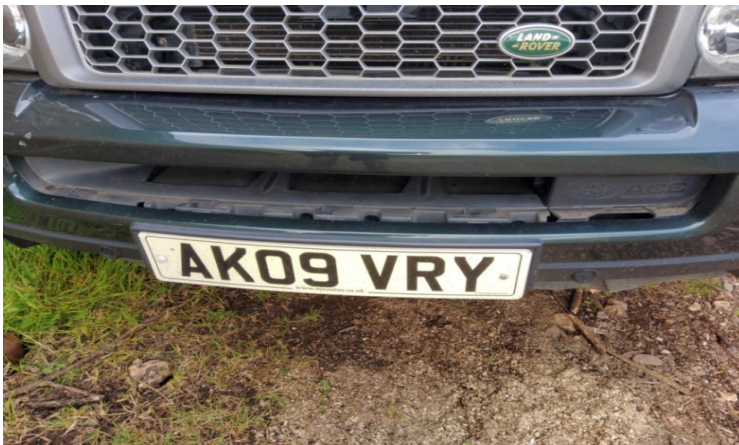
Impact Area

The vehicle has suffered moderate collision/impact damage to the right hand front.

Please note the vehicle is unroadworthy due to the broken offside front fog lamp.
