**Our Ref:** htu26021

### TOTAL LOSS REPORT

**RE: Road traffic Accident: Waquas Ali: 16/05/2026**

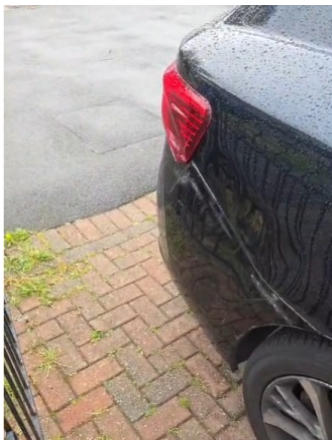
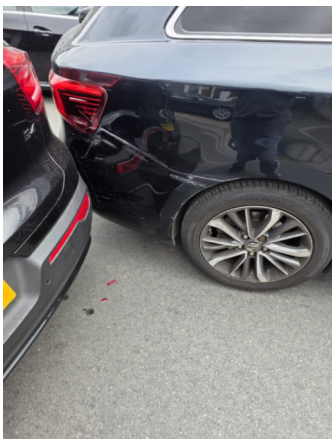
Impact Area

The vehicle has suffered moderate collision/impact damage to the right hand rear.

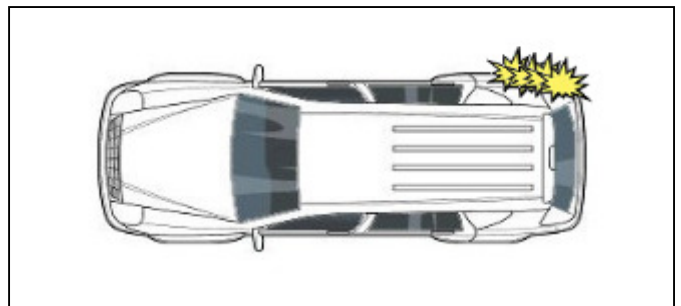
Please note the vehicle is unroadworthy due to the extent of panel distortion sustained to the offside. and the rear lamp is damaged/compromised. and the possible wheel, suspension and tyre damage.
