### **TOTAL LOSS REPORT**

**RE: Road traffic Accident: Mr Sajid Zumard: 05/11/2024**

| Make | <b>TOYOTA</b> | Registration | <b>SC03ZNH</b> |
| Model | <b>COROLLA T3 D4D</b> | Status | <b>T/Loss</b> |

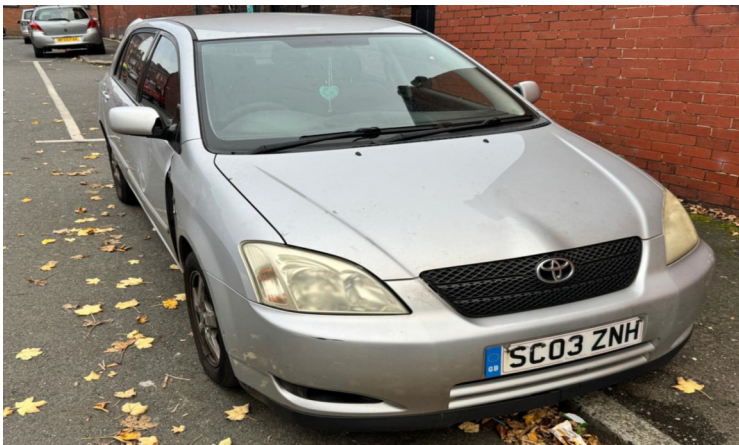
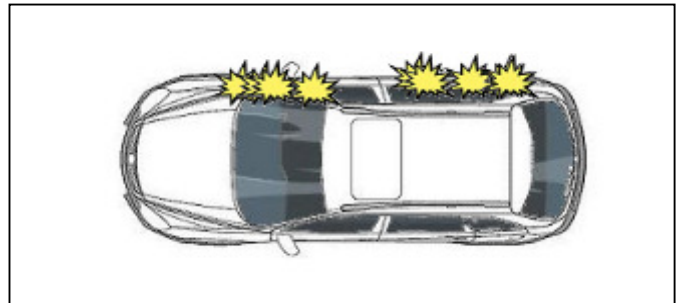
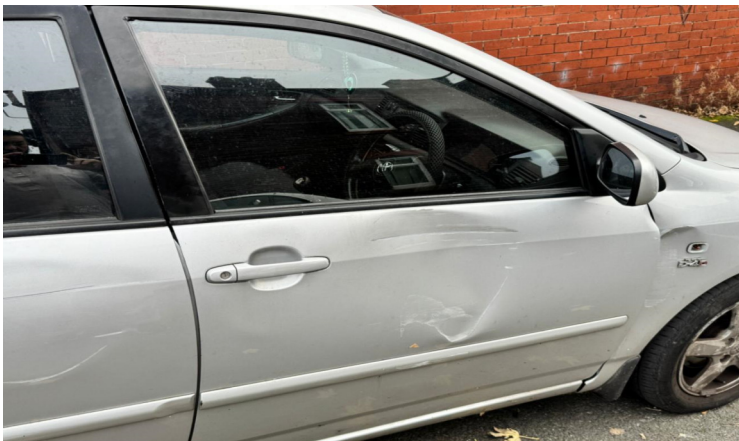
Impact Area

The vehicle has suffered moderate collision/impact damage to the right hand side.

11/11/2024 - Please note the vehicle is unroadworthy due to the extent of panel distortion sustained to the offside.
