**Our Ref:** mp220016

### **REPAIRABLE REPORT**

**RE: Road traffic Accident: Nadeem Chaudhry: 16/08/2022**

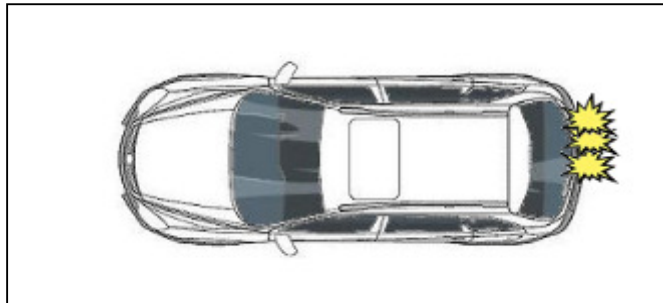
Impact Area

| Engineer Value | <b>£3,000.00</b> | Impact Magnitude | <b>Light to Moderate</b> |

The vehicle has suffered light to moderate collision/impact damage to the rear.
