26-1805416/2373541

# Total Loss Damage Assessment Report

| Model | Vivaro 2900 Cdti |
| Registration | DY17UVA |

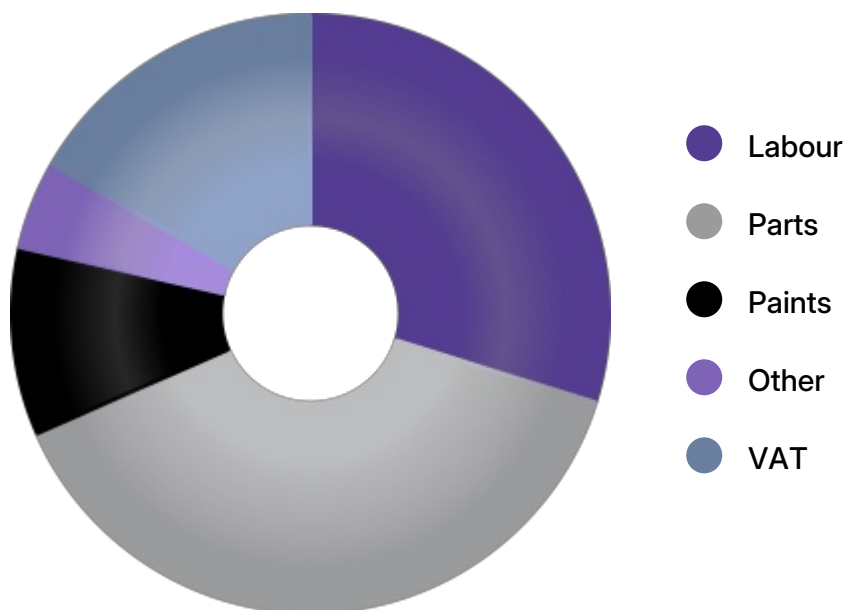
Repair Cost Breakdown

### Repair Costs Calculations

| Hours | 35.10 |
| Total Labour | £2,923.13 |
| Parts | £3,787.27 |
| Paints / Materials | £994.28 |
| Specialist / Other Items | £468.43 |
| Total Estimated Cost | £9,807.73 |

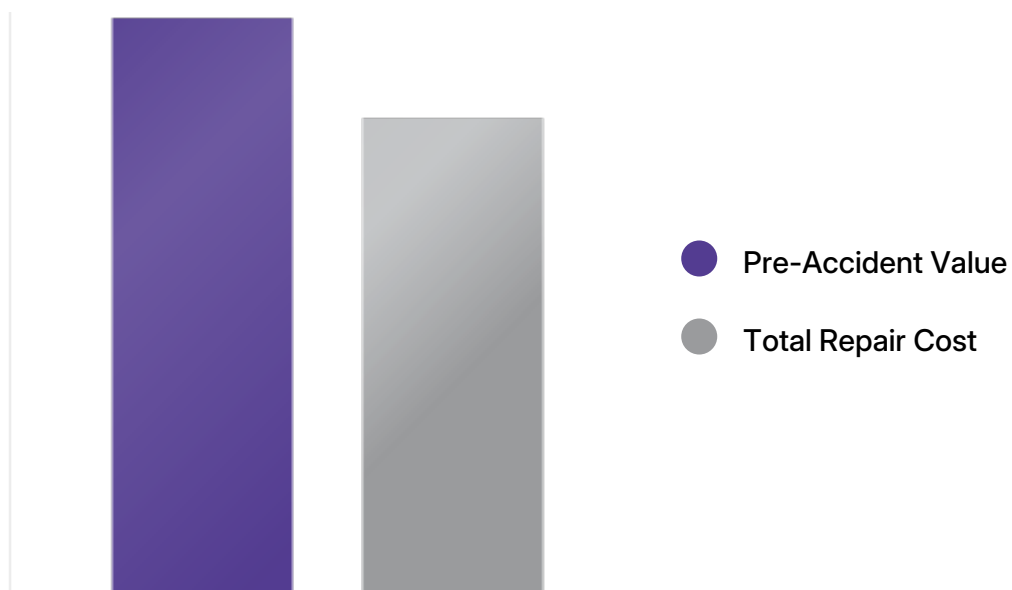
Pre-Accident Value -v- Total Repair Cost

| Engineer's Value | £11,894.00 |

Having examined the damage as presented, we have estimated repair times and methods, which are detailed below. We would recommend the vehicle to be dealt with on a total loss basis. The damage sustained to the vehicle would render the salvage as category 'S' (structural total loss) in accordance with the Salvage Code Of Practice.

We would suggest settlement be sought at a net figure of £10,228.84, being the pre-accident value, less the anticipated salvage value.
