## To the Court REPAIRABLE REPORT

| Vehicle: <b>LAND ROVER RANGE ROVER EVOQUE</b> | | Colour: <b>WHITE</b> | Speedo: <b>85215</b> Miles | |
| Reg No: <b>J22UCH</b> | Registered: <b>Mar 2015</b> | Type: <b>Estate</b> | Trans: <b>Automatic</b> | |
| Damage: <b>Moderate Collision/Impact RH Side Complete Vehicle</b> | Incident: <b>11/04/2026</b> | L/H/F Tyre <b>Not Kno</b> | L/H/R Tyre <b>Not Kno</b> | |

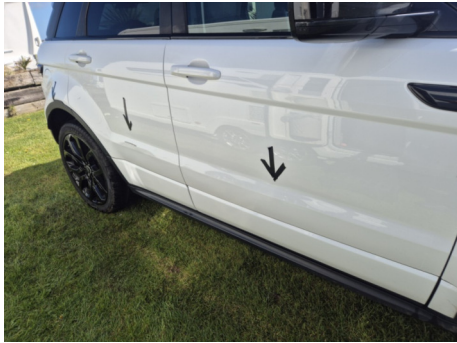
4\_CLVDamage-V1-4.jpg

The vehicle has suffered moderate collision/impact damage to the right hand side complete vehicle.
