# Total Loss Damage Assessment Report

| Make | Audi |
| Model | Q4 E-tron Black Ed 45<br>Quattro |
| Registration | SA75GZN |

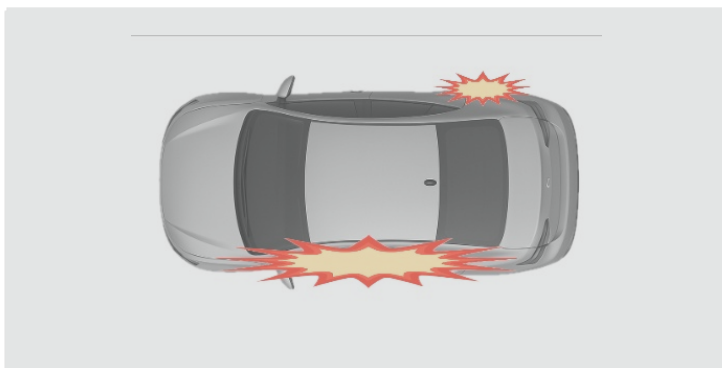
**Impact Diagram**

| Impact Magnitude | Heavy |

Having examined the damage as presented, we have estimated repair times and methods, which are detailed below. We would recommend the vehicle to be dealt with on a total loss basis. The damage sustained to the vehicle would render the [salvage](#) as category 'S' (structural total loss) in accordance with the [Salvage Code Of Practice](#).
