### **TOTAL LOSS REPORT**

**RE: Road traffic Accident: Gabriel Grancia: 14/04/2026**

| Make | <b>BMW</b> | Registration | <b>AU62LCG</b> |
| Model | <b>640D SE AUTO</b> | Status | <b>T/Loss</b> |

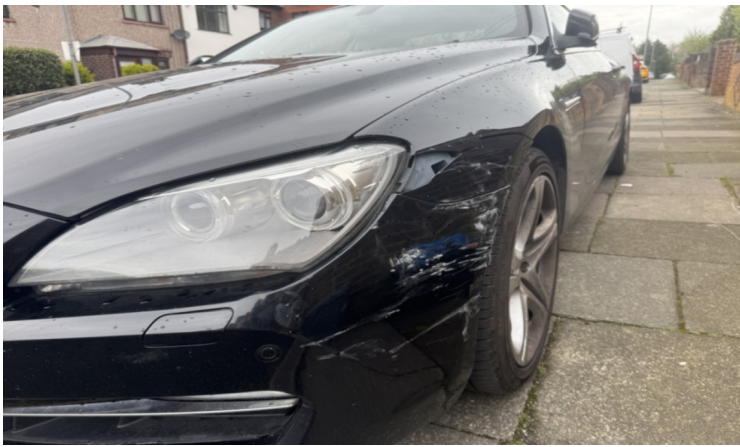
Impact Area

The vehicle has suffered moderate collision/impact damage to the left hand front.

Please note the vehicle is unroadworthy due to the extent of panel distortion sustained to the nearside front.
