### **TOTAL LOSS REPORT**

**RE: Road traffic Accident: John Brown-Hicks : 08/08/2025**

| Make | <b>VOLKSWAGEN</b> | Registration | <b>CE59GXP</b> |
| Model | <b>TOURAN SE TDI 105</b> | Status | <b>T/Loss</b> |

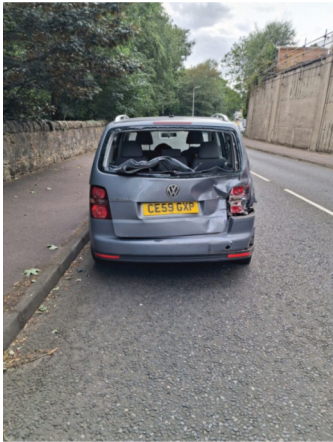
Impact Area

The vehicle has suffered moderate collision/impact damage to the right hand rear.

19/08/2025 - Please note the vehicle is unroadworthy due to the extent of panel distortion sustained to the offside rear.
