### **TOTAL LOSS REPORT**

**RE: Road traffic Accident: Ms Mary Mccuaig: 17/04/2026**

**Our Ref:** qdos261048

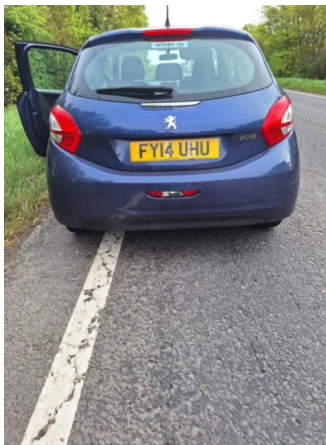
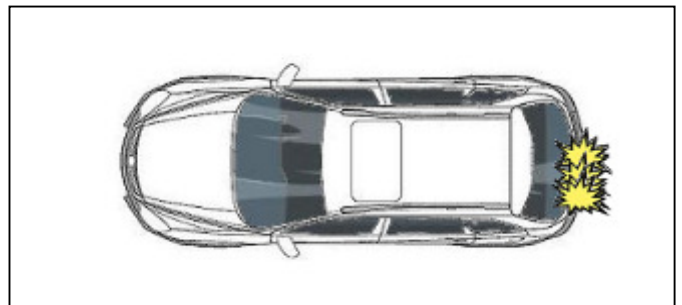
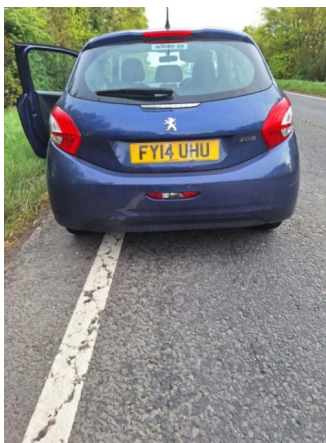
Impact Area

The vehicle has suffered moderate collision/impact damage to the rear.
