### **TOTAL LOSS REPORT**

**RE: Road traffic Accident: Mr Jesno Joy: 17/03/2026**

| Make | <b>TOYOTA</b> | Registration | <b>WF10XAS</b> |
| Model | <b>AURIS TR VALVEMATI</b> | Status | <b>T/Loss</b> |

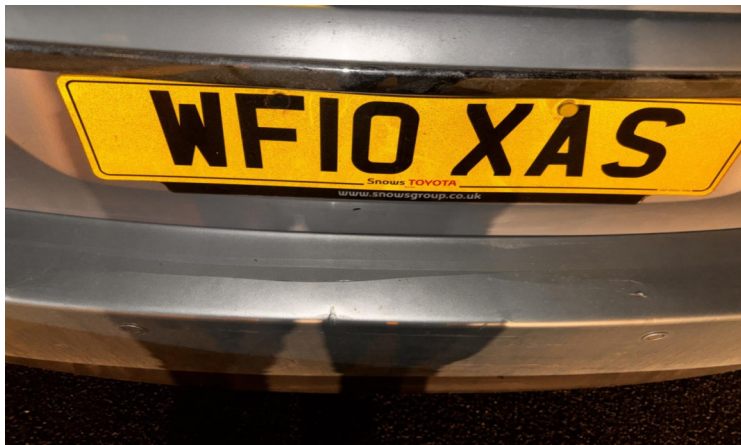
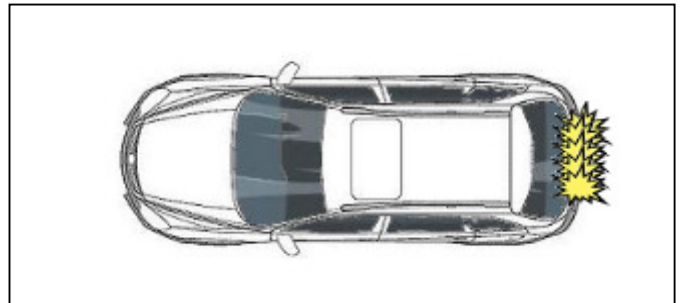
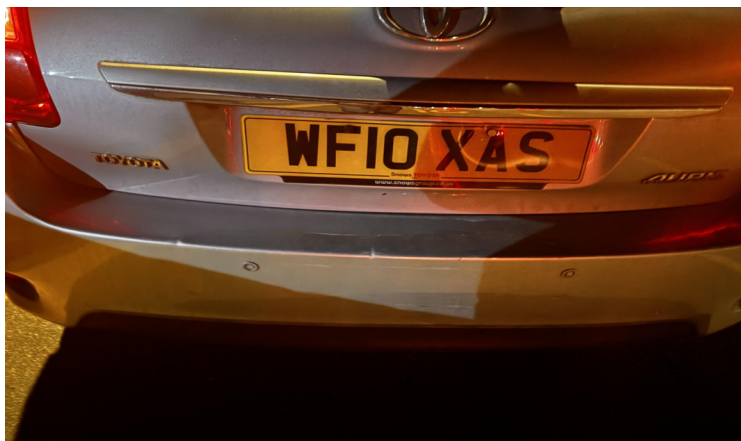
Impact Area

The vehicle has suffered moderate collision/impact damage to the rear.
