### REPAIRABLE REPORT

**RE: Road traffic Accident: Mr Anthony Mohammed Cauchie: 13/04/2026**

| Make | <b>VOLKSWAGEN</b> | Registration | <b>GM23KPZ</b> |
| Model | <b>GOLF LIFE TDI S-A</b> | Status | <b>Repair</b> |

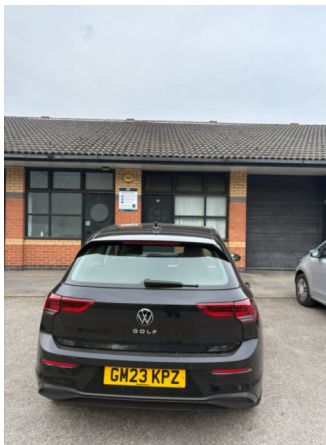
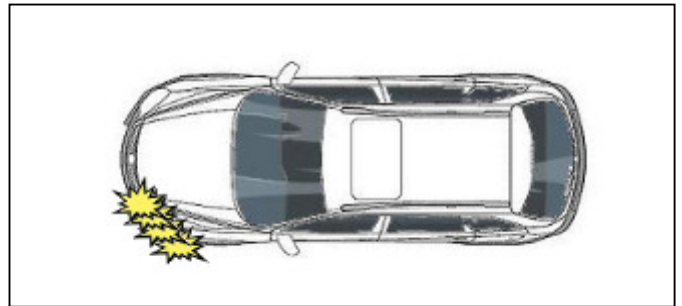
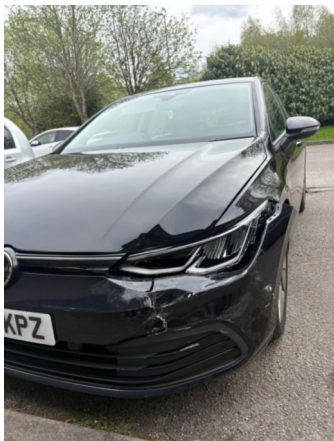
Impact Area

The vehicle has suffered moderate to heavy collision/impact damage to the left hand front.

Please note the vehicle is unroadworthy due to the extent of panel distortion sustained to the front end, broken headlamp and insecure front bumper.
