## REPAIRABLE REPORT

### **RE: Road traffic Accident: Karen Reid: 17/08/2022**

### **DESKTOP ASSESSMENT**

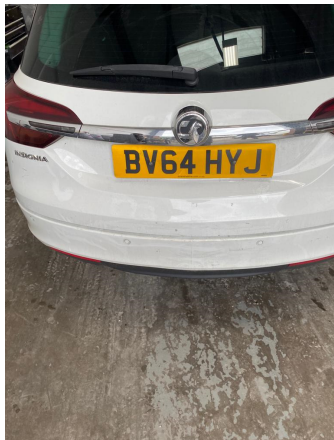
Impact Area

The vehicle has suffered moderate collision/impact damage to the rear.

23/08/2022 - Please note the vehicle is unroadworthy due to the damaged/insecure exhaust.
