26-1821108/2395402

# Total Loss Damage Assessment Report

| Model | Xe Portfolio I Auto |
| Registration | EX67EHY |

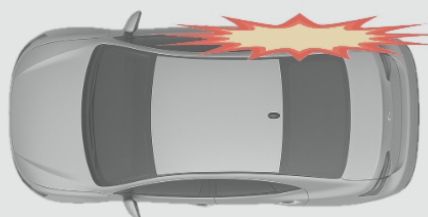
**Impact Diagram**

| Impact Magnitude | Moderate |

| R/r Door | R/r Edge Protection | R/r Door Foil Cover |
| R/side Panel Rear | R/r Tyre | R/r Pressure Valve |

Having examined the damage as presented, we have estimated repair times and methods, which are detailed below. We would recommend the vehicle to be dealt with on a total loss basis. The damage sustained to the vehicle would render the salvage as category 'N' (non structural damage) in accordance with the [Salvage Code Of Practice](#).
