### **TOTAL LOSS REPORT**

**RE: Road traffic Accident: Abi Umal: 17/04/2026**

**Our Ref:** ap.qdos261068

**Date:** 23/04/2026

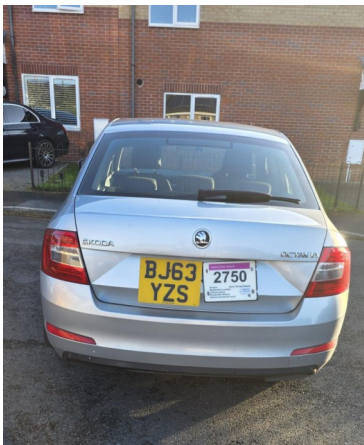
Impact Area

The vehicle has suffered light collision/impact damage to the right hand rear.
