### TOTAL LOSS REPORT

**RE: Road traffic Accident: Id Said Hussein : 13/01/2026**

| Make | <b>SUZUKI</b> | Registration | <b>LB08FOA</b> |
| Model | <b>SPLASH GLS+ AUTO</b> | Status | <b>T/Loss</b> |

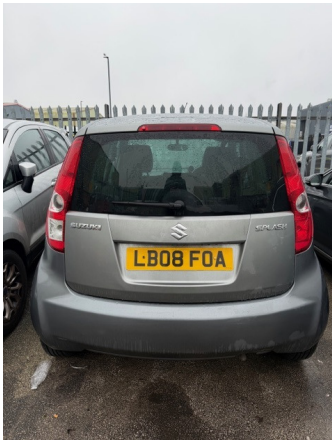
Impact Area

The vehicle has suffered moderate collision/impact damage to the right hand side.

Please note the vehicle is unroadworthy due to the extent of panel distortion sustained to the offside.
