**Our Ref:** oak25155

### TOTAL LOSS REPORT

**RE: Road traffic Accident: Andrew Whiteford: 08/05/2025**

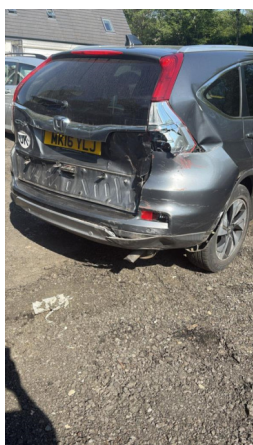
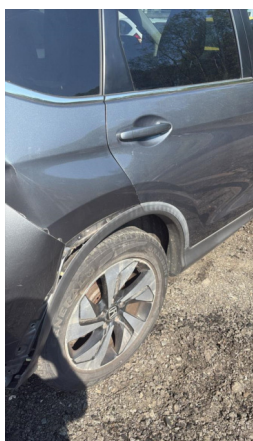
Impact Area

The vehicle has suffered heavy collision/impact damage to the rear.

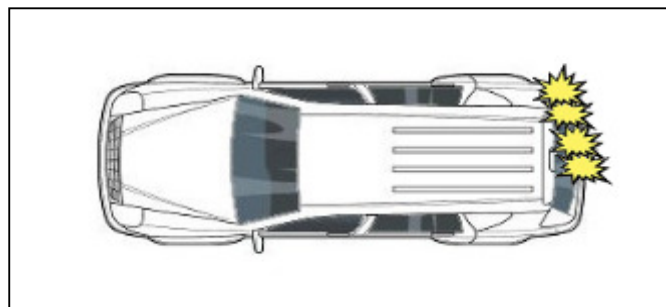
15/05/2025 - Please note the vehicle is unroadworthy as the rear body has been compromised.
