### **TOTAL LOSS REPORT**

**RE: Road traffic Accident: Adama Barry: 13/08/2022**

| Make | <b>CITROEN</b> | Registration | <b>MK59AXY</b> |
| Model | <b>C4 VTR HDI 90</b> | Status | <b>T/Loss</b> |

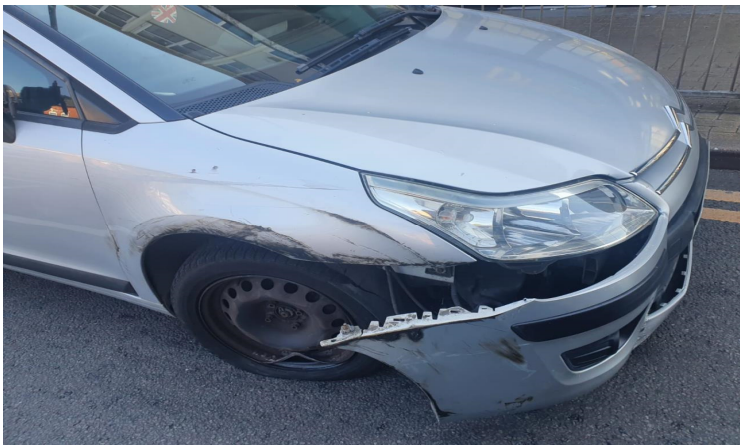
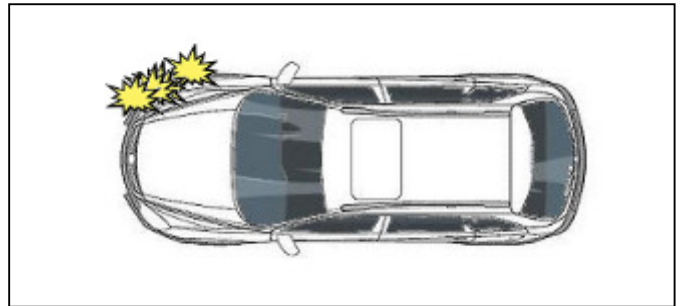
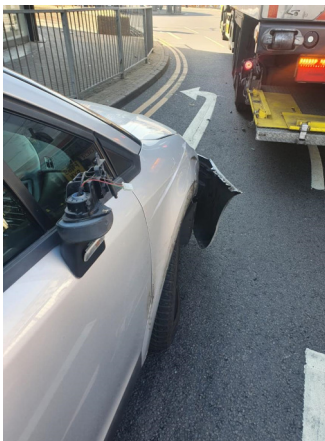
Impact Area

The vehicle has suffered moderate collision/impact damage to the right hand front.

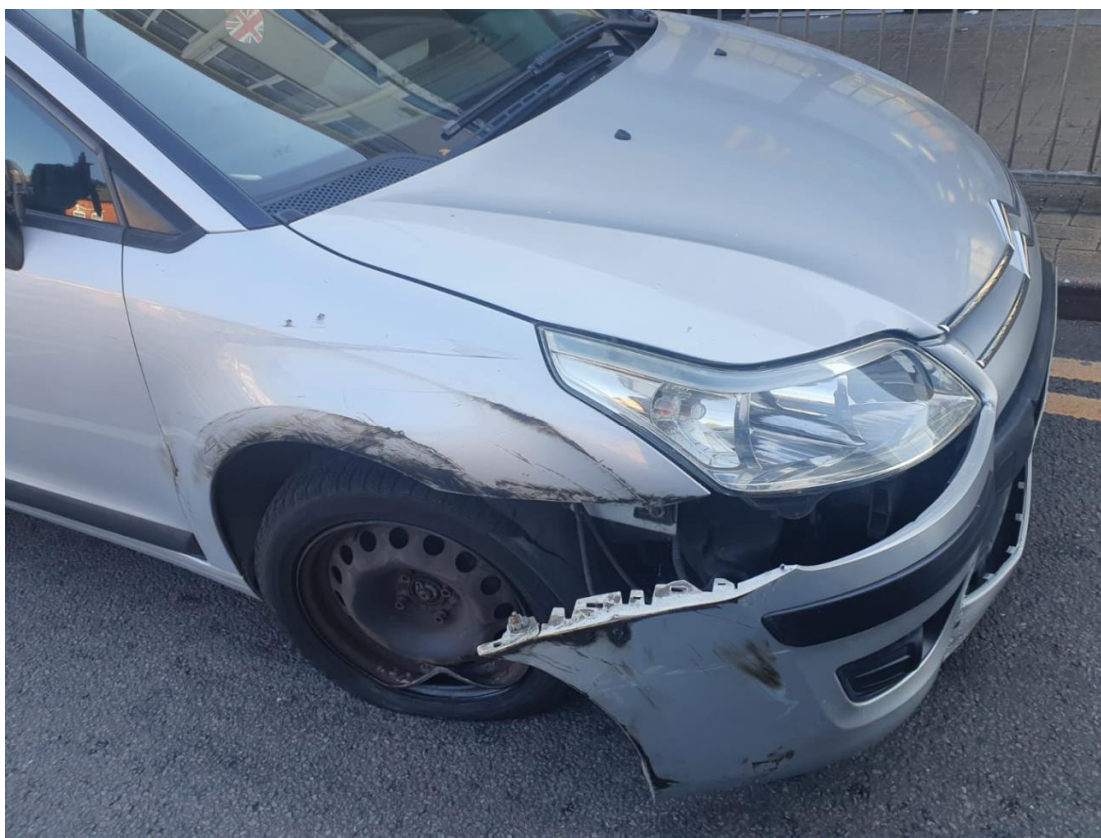
Clientsvehicledamage2jpeg-V1(1).jpeg

23/08/2022 - Please note the vehicle is unroadworthy due to the damaged offside front wheel.

Front Bumper Lining  
Right Headlamp, Complete (with Indicator)  
Right One Front Wing and Front Bumper  
Right Front Door Lower Cover  
Right Front Suspension Strut w/Shock Absorber  
Right Front Wheel

Front Bumper Bracket Kit  
Right Front Wing  
Right Front Wing Liner  
Right Front Suspension Arm  
Right Front Steering Knuckle with Hub

Right Front Door Shell
