### **TOTAL LOSS REPORT**

#### **RE: Road traffic Accident: Mr Keegan Foden: 17/05/2026**

| Make | <b>VAUXHALL</b> | Registration | <b>RJ13YHO</b> |
| Model | <b>CORSA ENERGY AC</b> | Status | <b>T/Loss</b> |

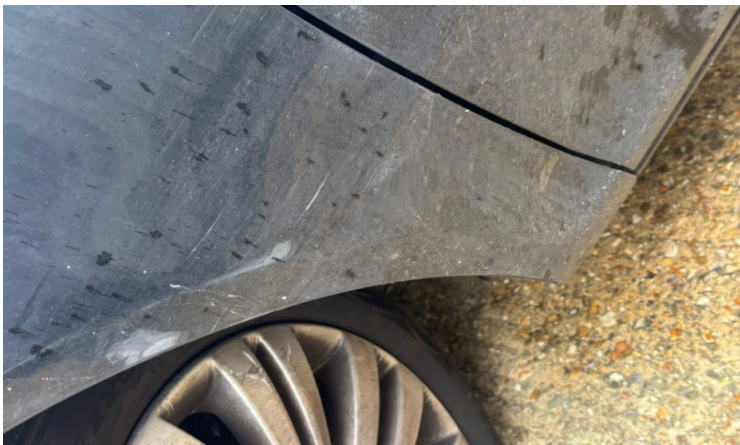
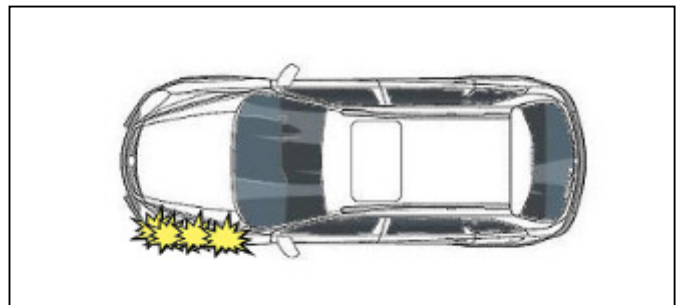
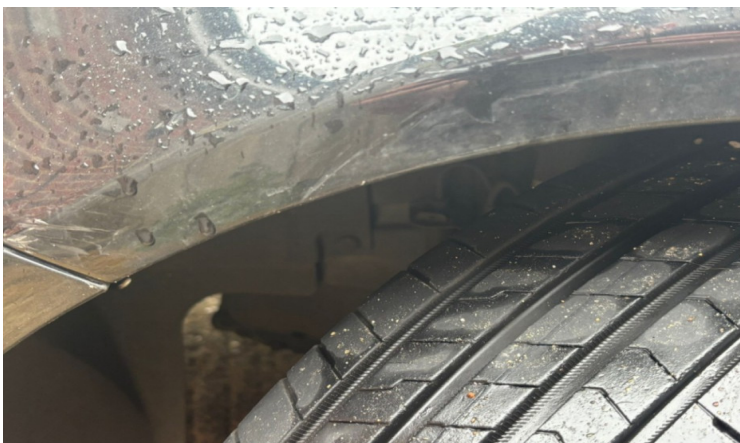
Impact Area

The vehicle has suffered moderate collision/impact damage to the left hand front.
