### **TOTAL LOSS REPORT**

**RE: Road traffic Accident: Derek Smith: 21/04/2025**

**Our Ref:** oak25128

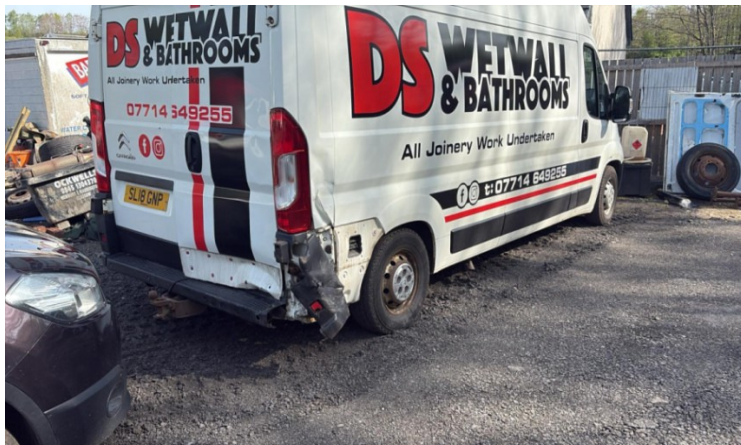
Impact Area

The vehicle has suffered moderate collision/impact damage to the right hand rear.

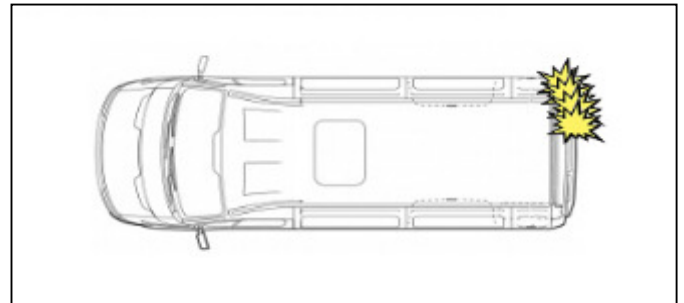
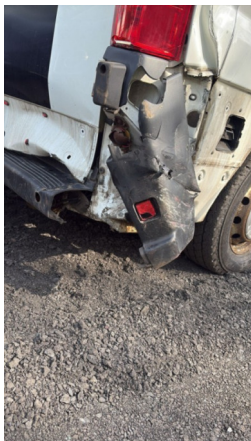
01/05/2025 - Please note the vehicle is unroadworthy as the rear body has been comprised.
