### **TOTAL LOSS REPORT**

**RE: Road traffic Accident: Mr Kamalu Justin: 10/04/2026**

| Make | <b>BMW</b> | Registration | <b>WG55NHC</b> |
| Model | <b>325I SE AUTO</b> | Status | <b>T/Loss</b> |

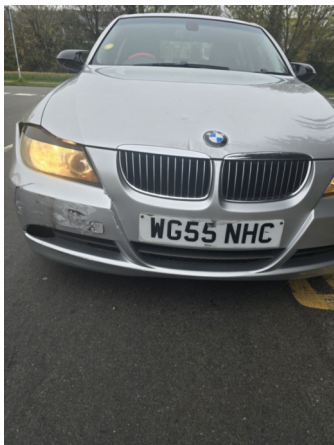
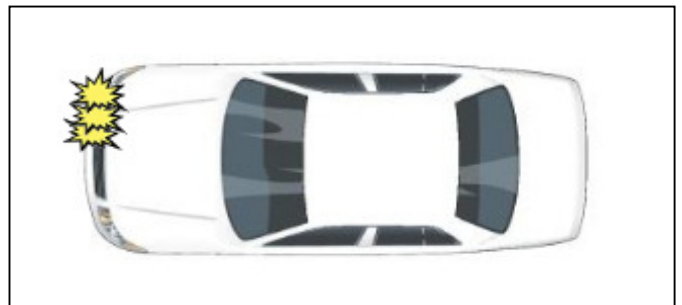
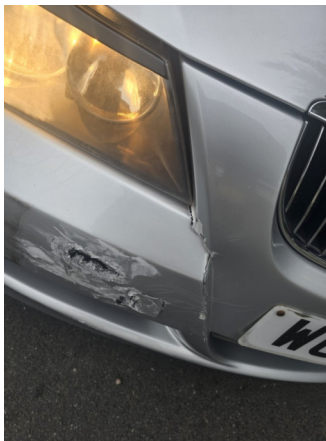
Impact Area

The vehicle has suffered light to moderate collision/impact damage to the front.

Please note the vehicle is unroadworthy due to the broken/insecure front bumper.
