### **REPAIRABLE REPORT**

#### **RE: Road traffic Accident: Blair Vick: 02/07/2022**

| Make | <b>SEAT</b> | Registration | <b>KV60KZH</b> |
| Model | <b>LEON CUPRA TSI</b> | Status | <b>Repair</b> |

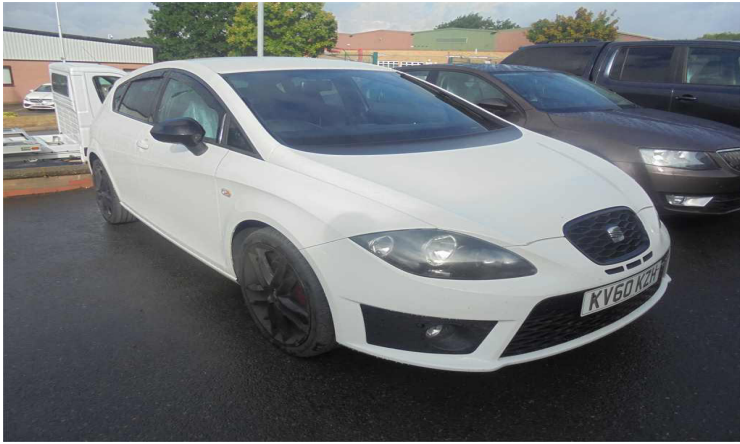
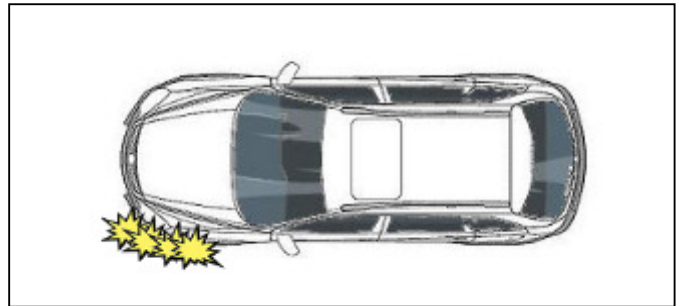
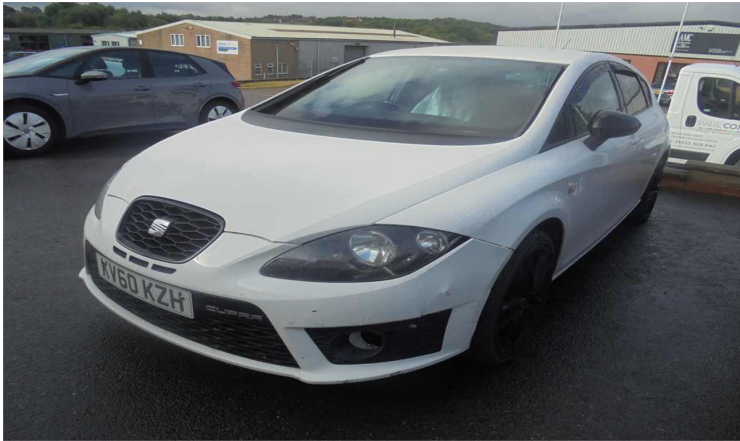
Impact Area

The vehicle has suffered moderate collision/impact damage to the left hand front.

Front Bumper  
L/F Upp Bumper Brkt  
Left Headlamp Assy  
L/F Wing Strut  
Pan. Repair Material

L/F Wing
