## REPAIRABLE REPORT

### **RE: Road traffic Accident: Martin Bull: 14/08/2022**

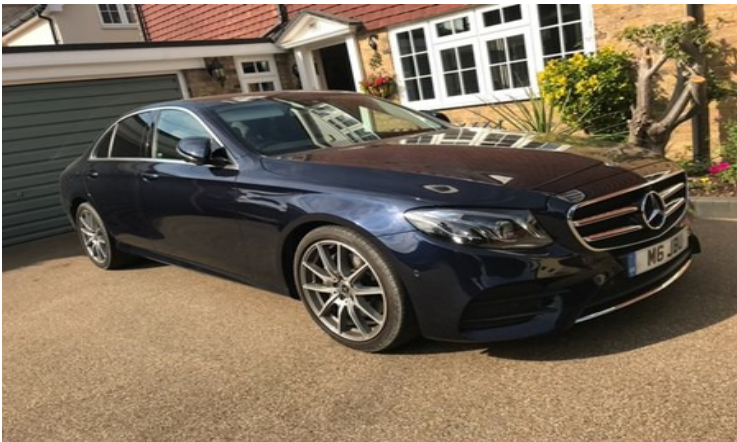
Impact Area

The vehicle has suffered light to moderate collision/impact damage to the right hand side.

Right Front Door Window Outer Channel Strip  
Right Rear Door Trim Support Kit

Right Rear Door Outer Window Channel Strip  
Right Rear Door Trim Screw

Right Rear Door Shell
