### **REPAIRABLE REPORT**

**RE: Road traffic Accident: Tracy Kirby: 09/08/2022**

| Make | <b>AUDI</b> | Registration | <b>T90PPE</b> |
| Model | <b>Q7 S LINE + TDI QUAT</b> | Status | <b>Repair</b> |

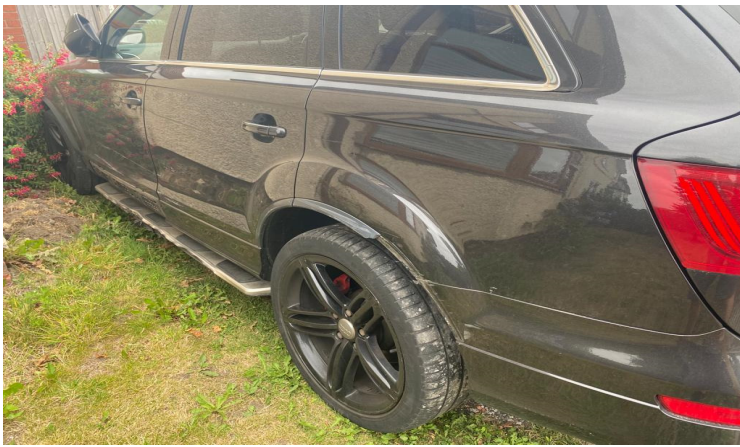
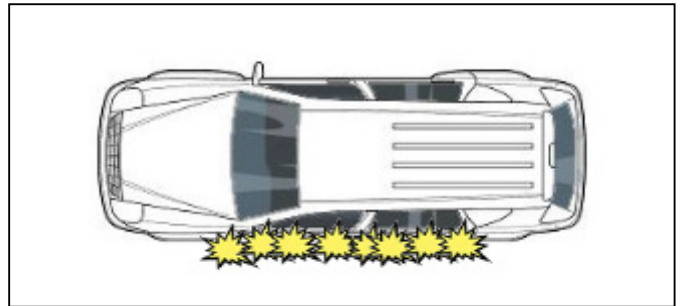
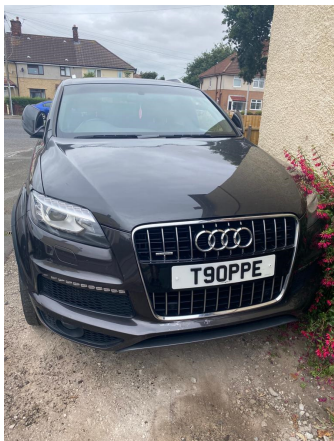
Impact Area

The vehicle has suffered moderate collision/impact damage to the left hand side.

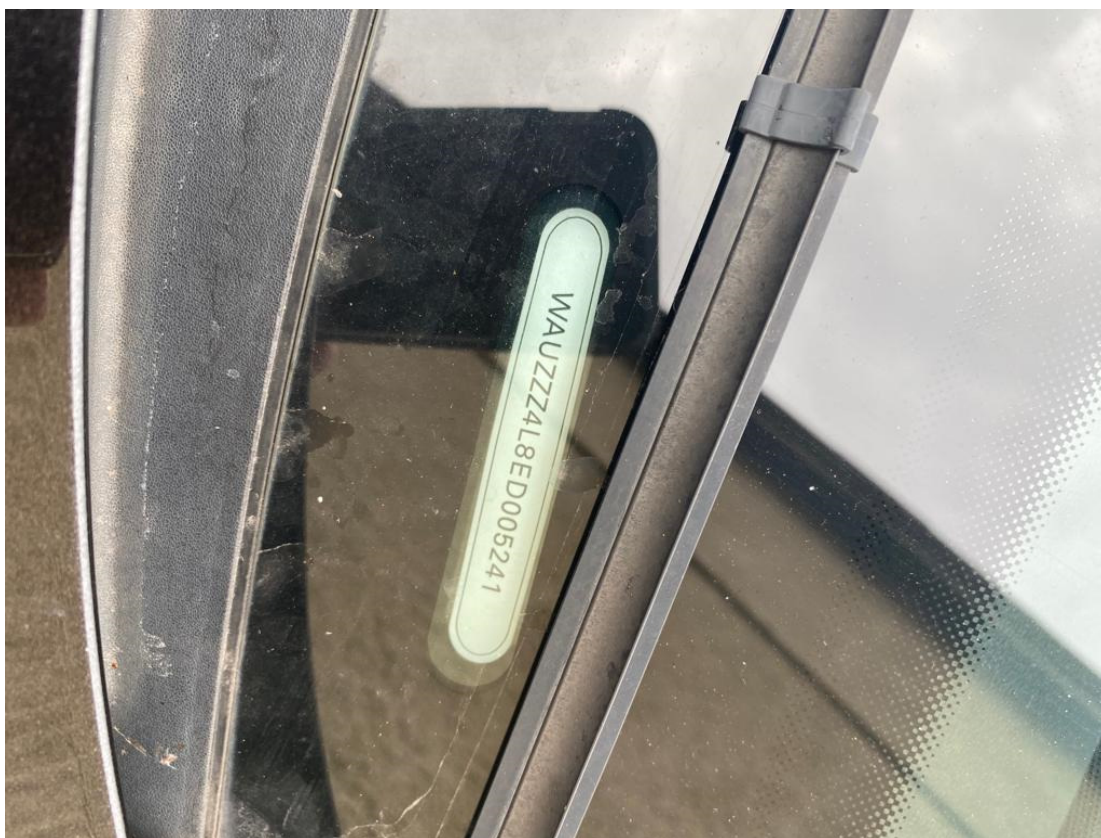
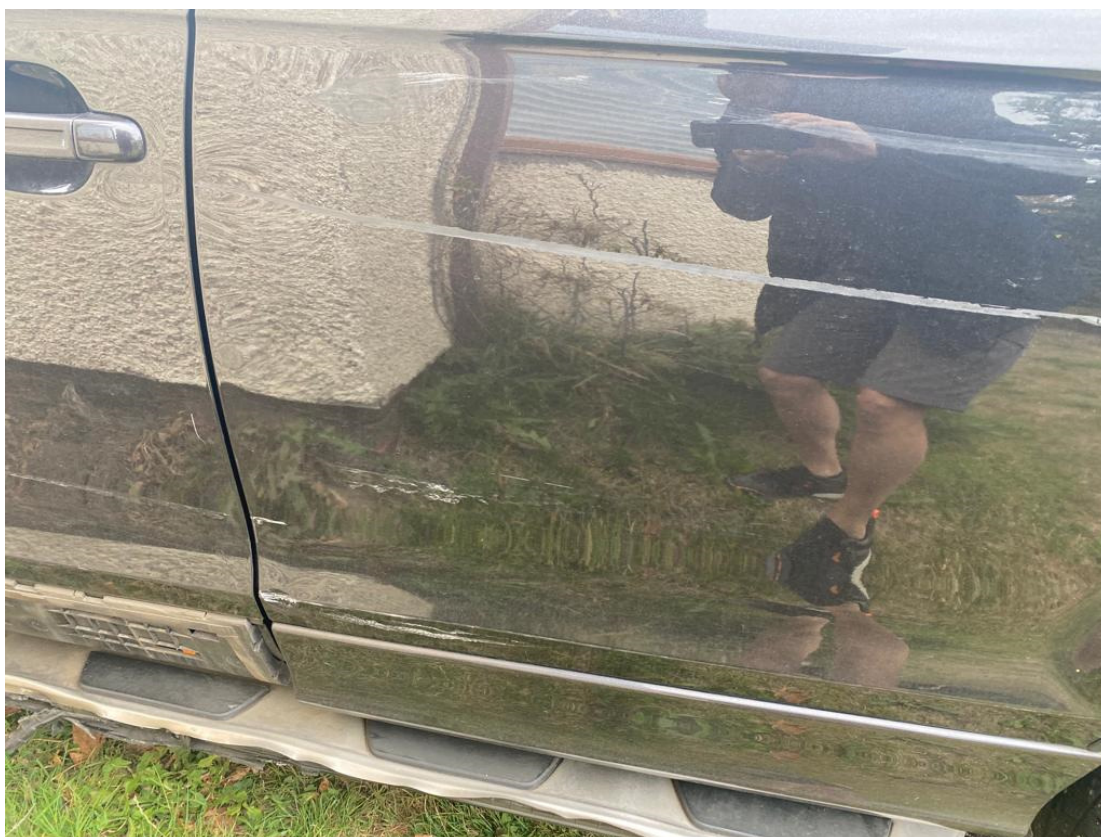
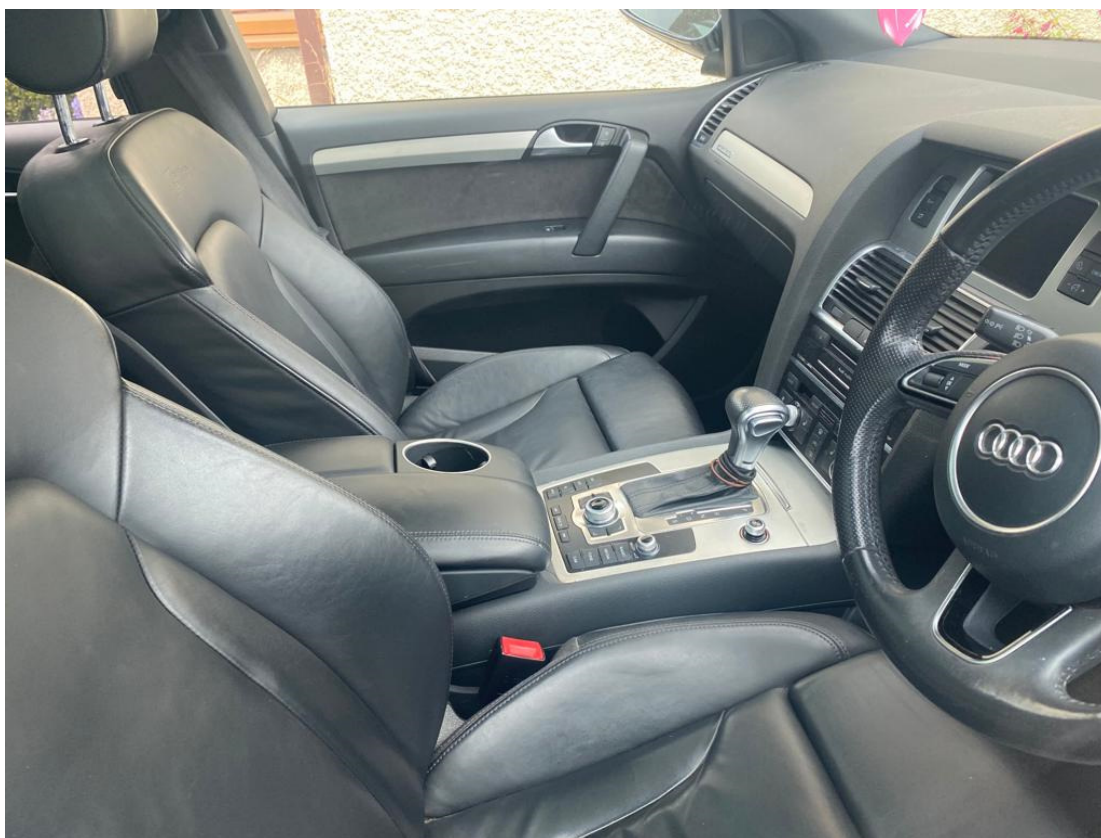
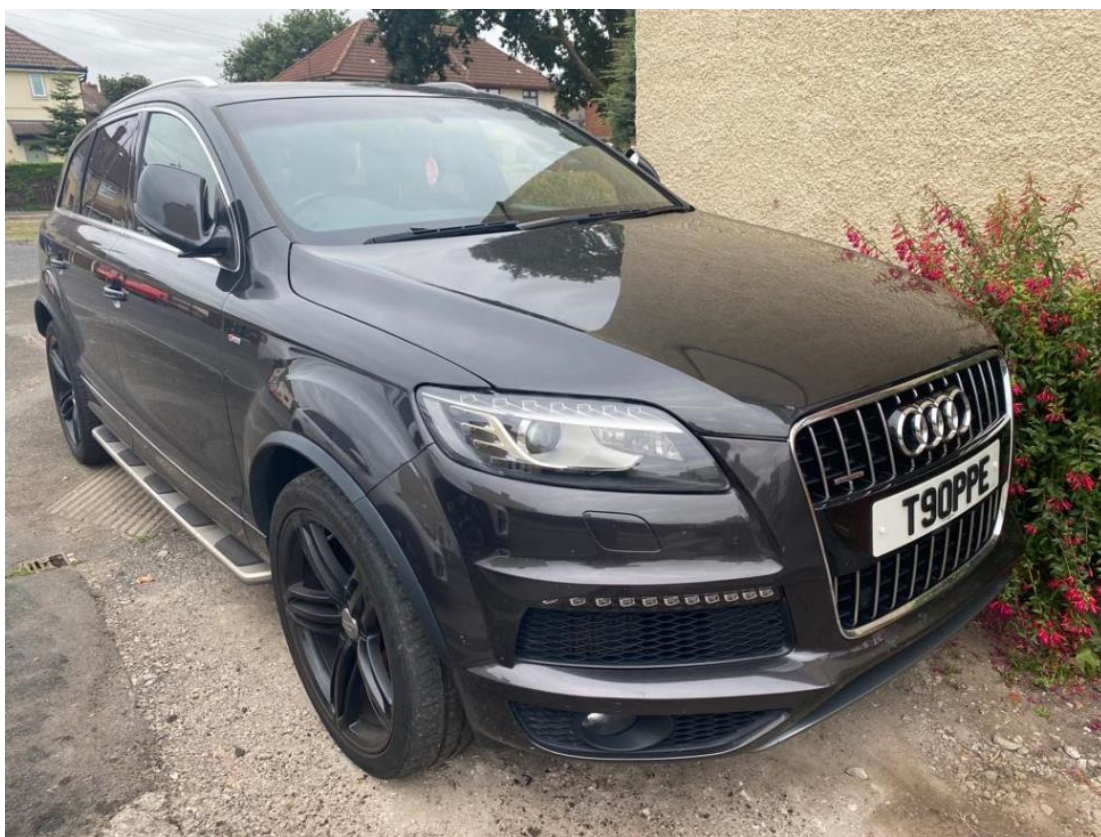
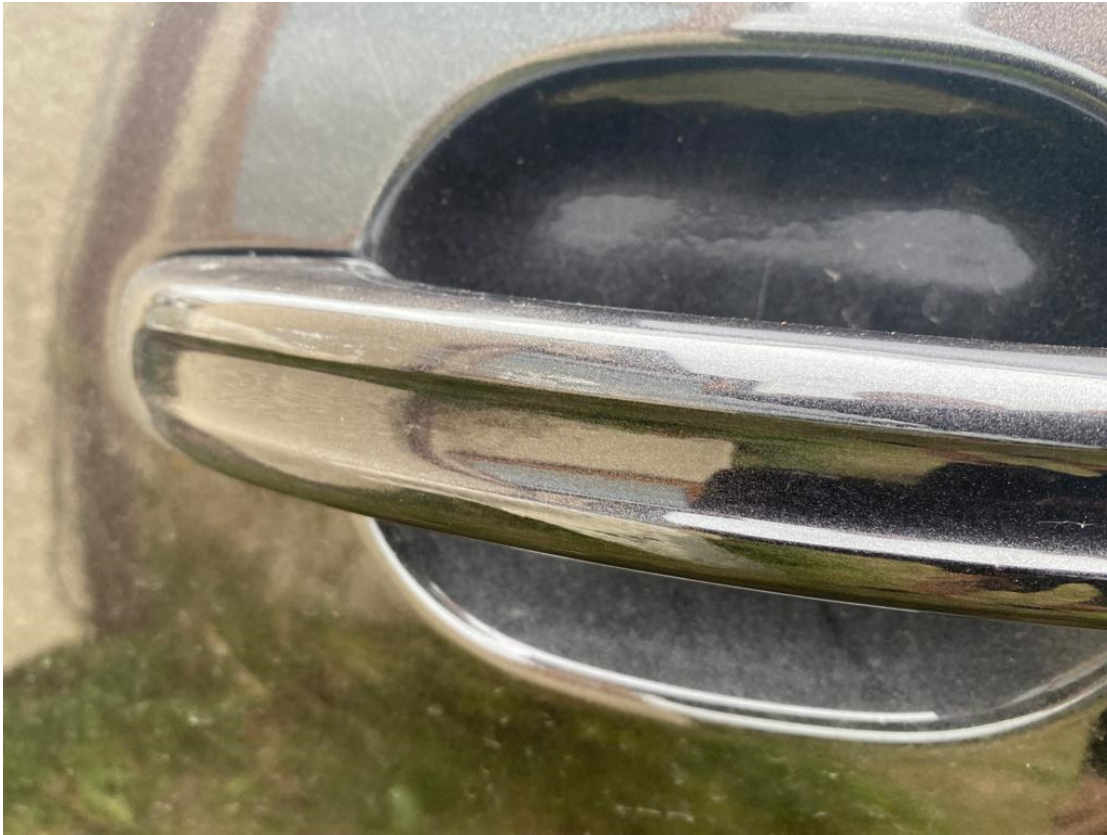
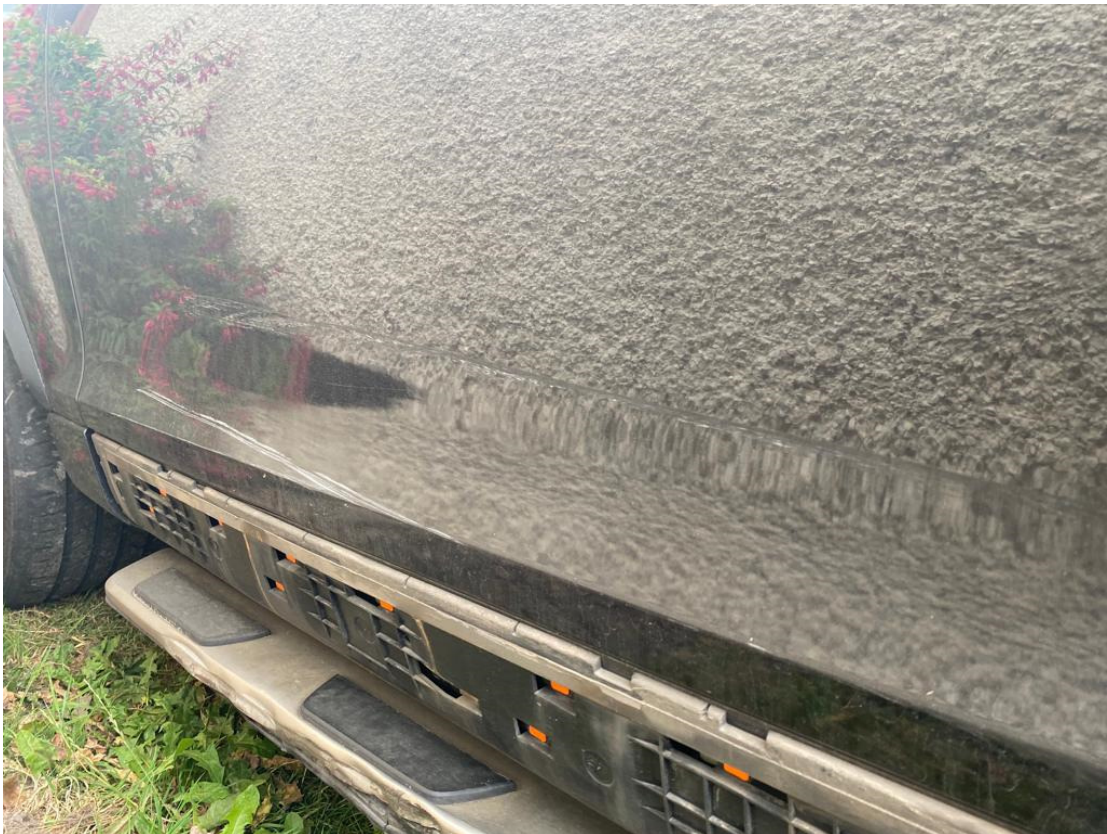
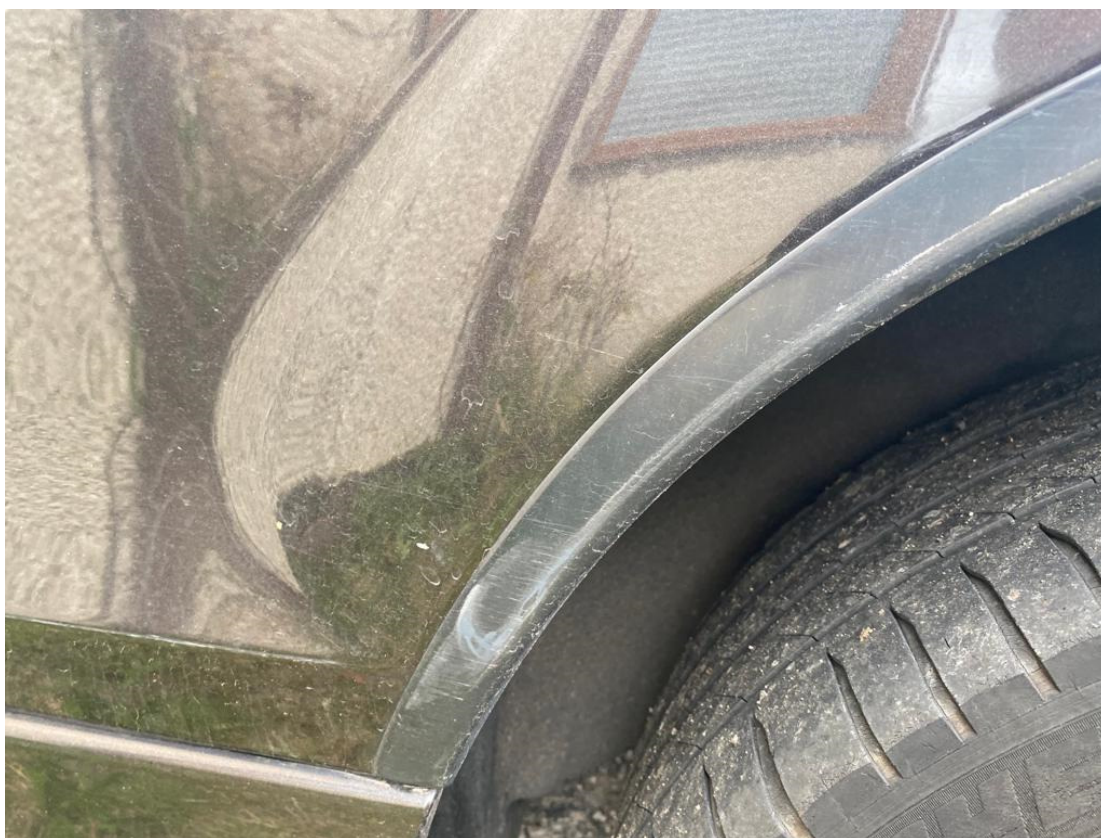
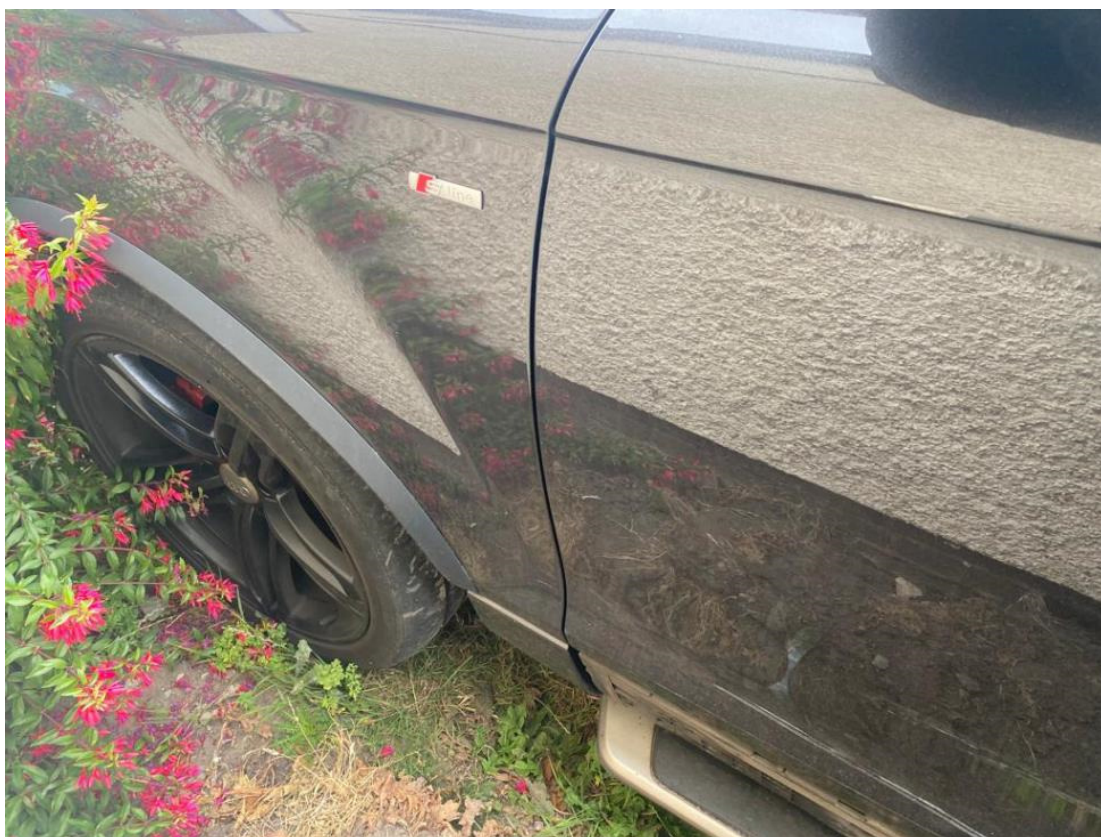
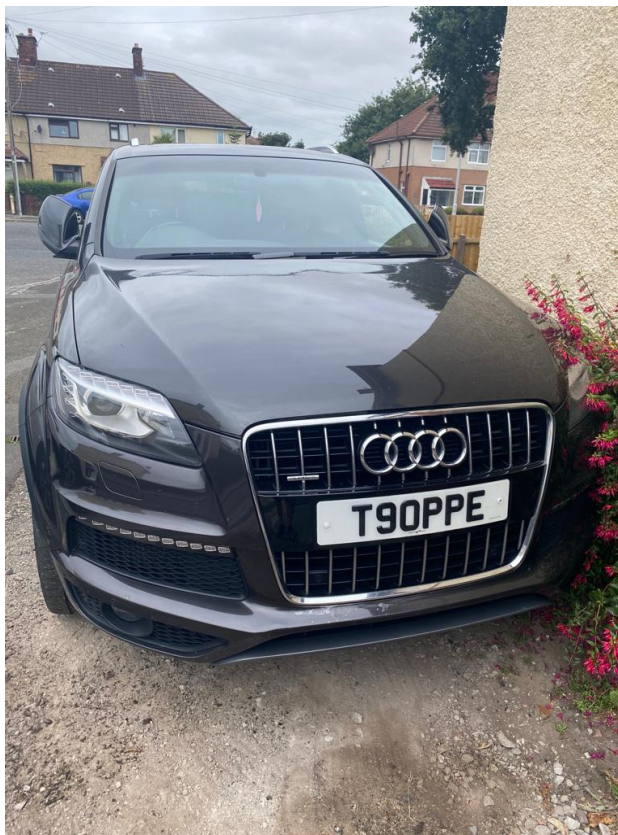
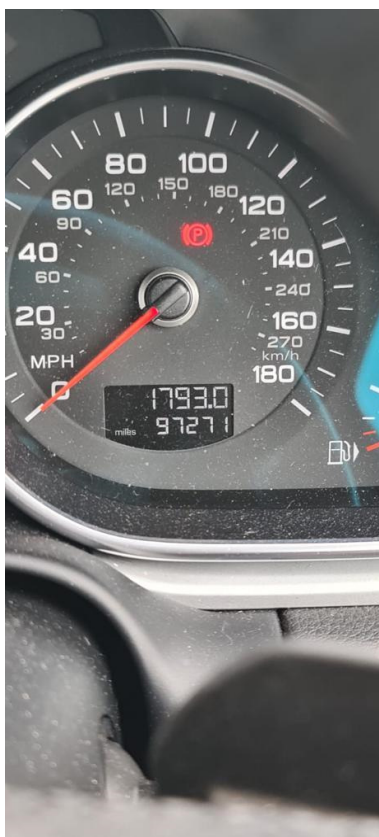
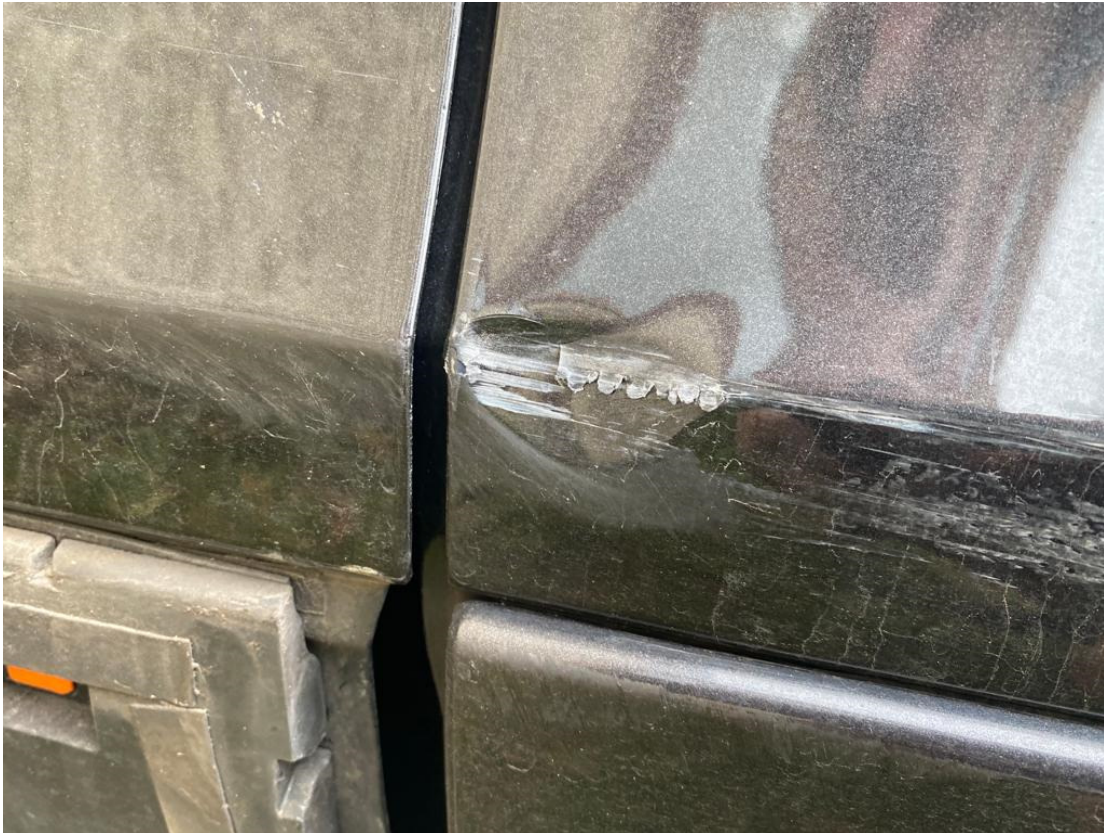
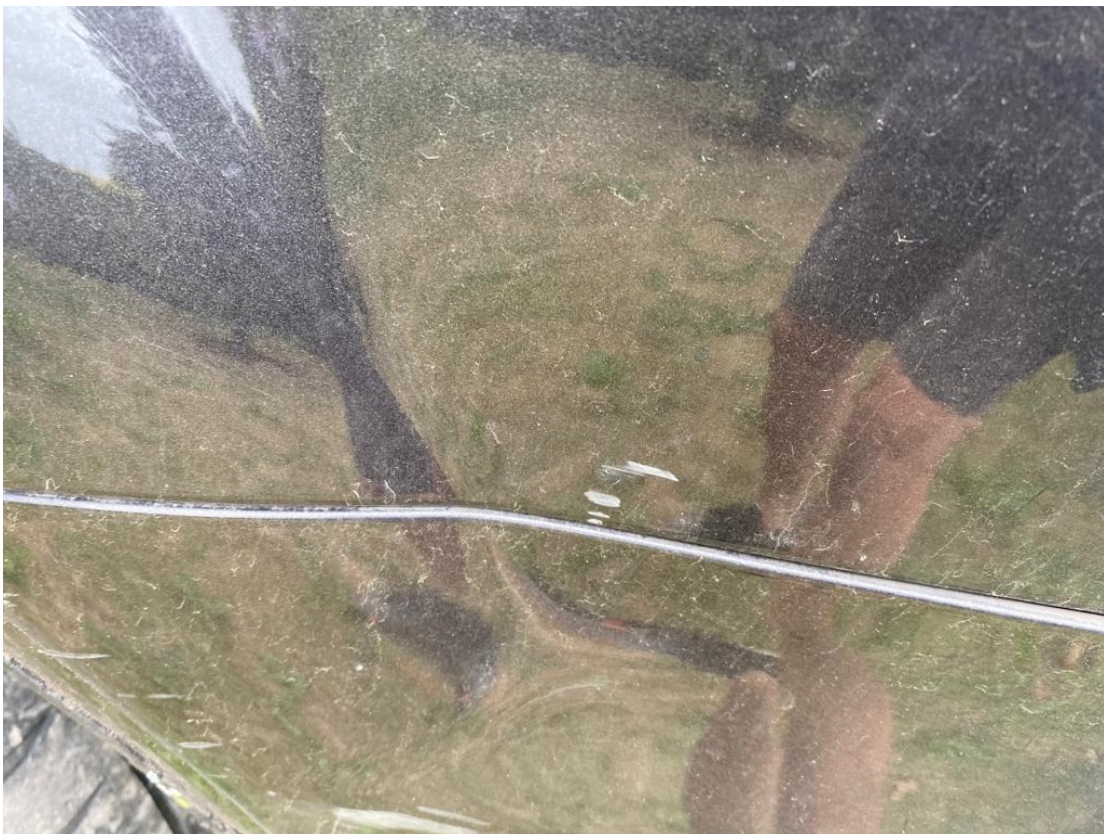
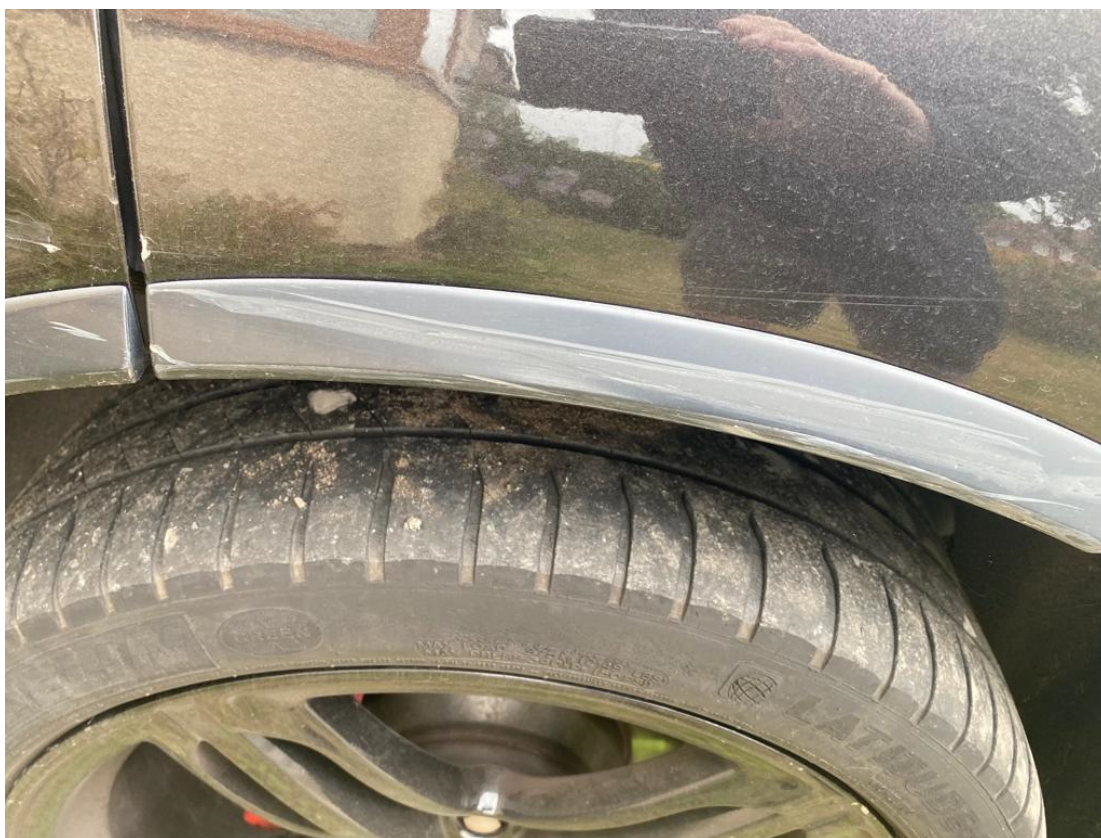
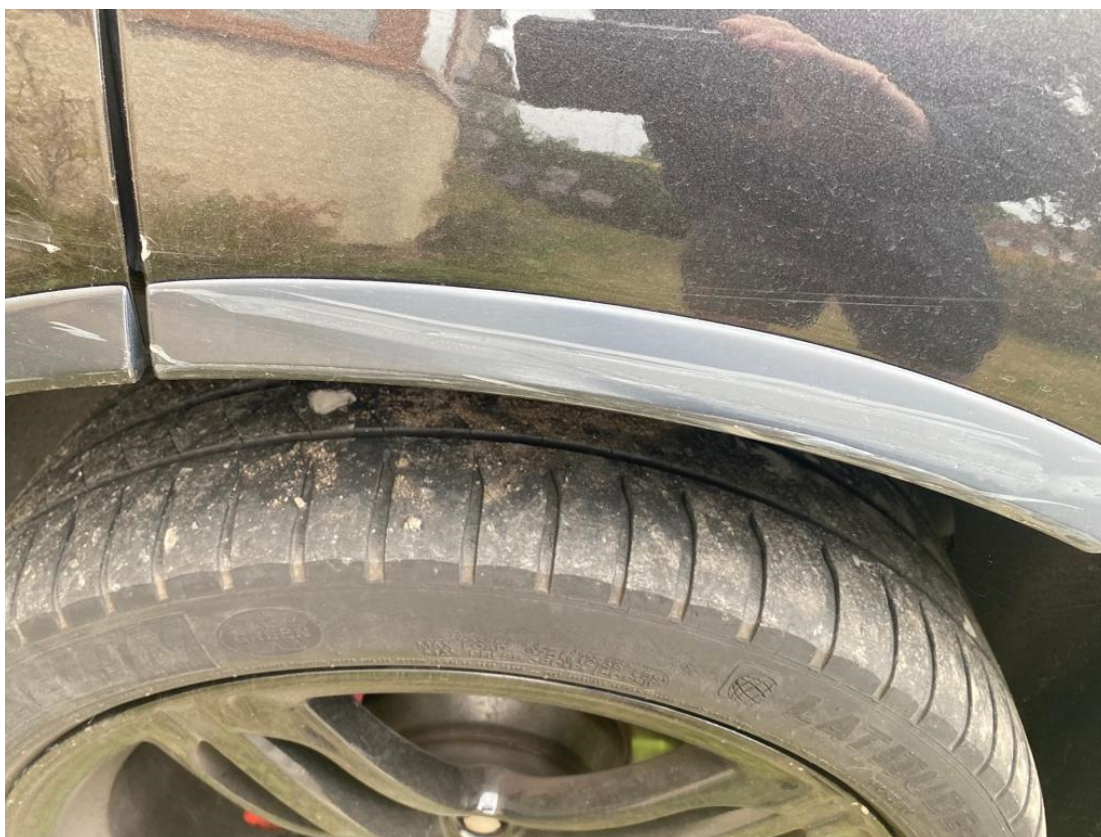
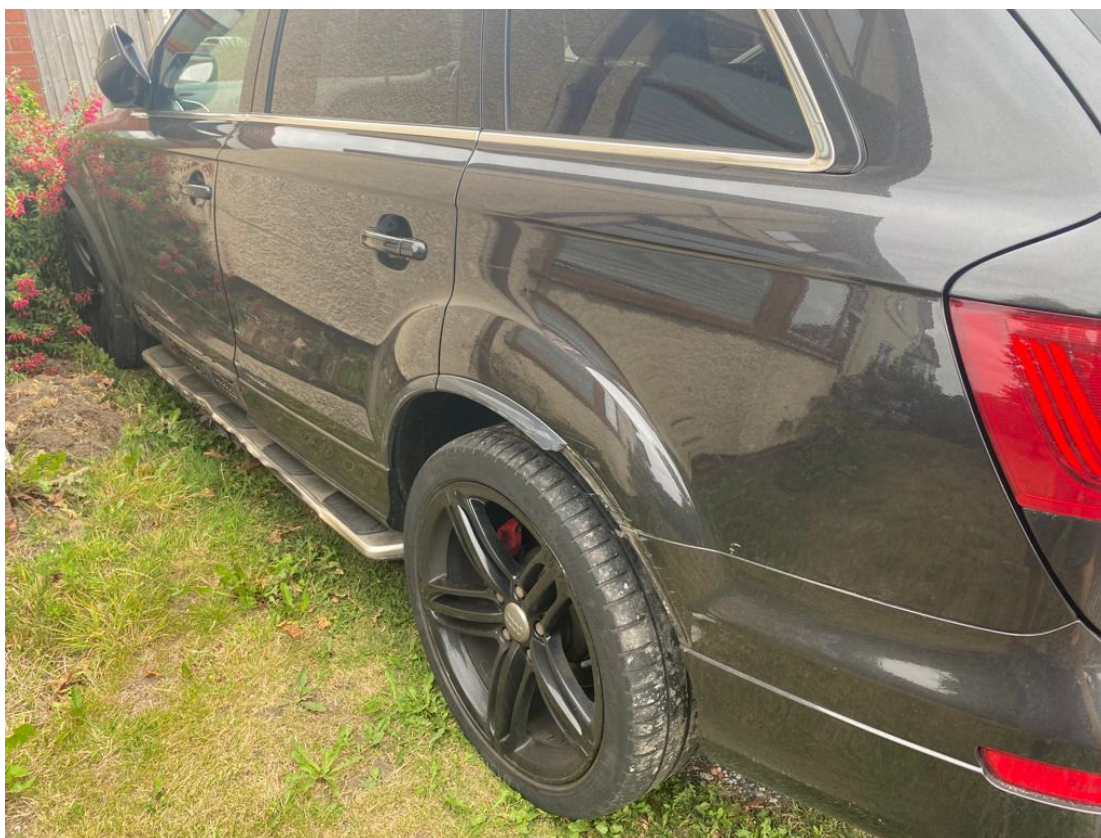
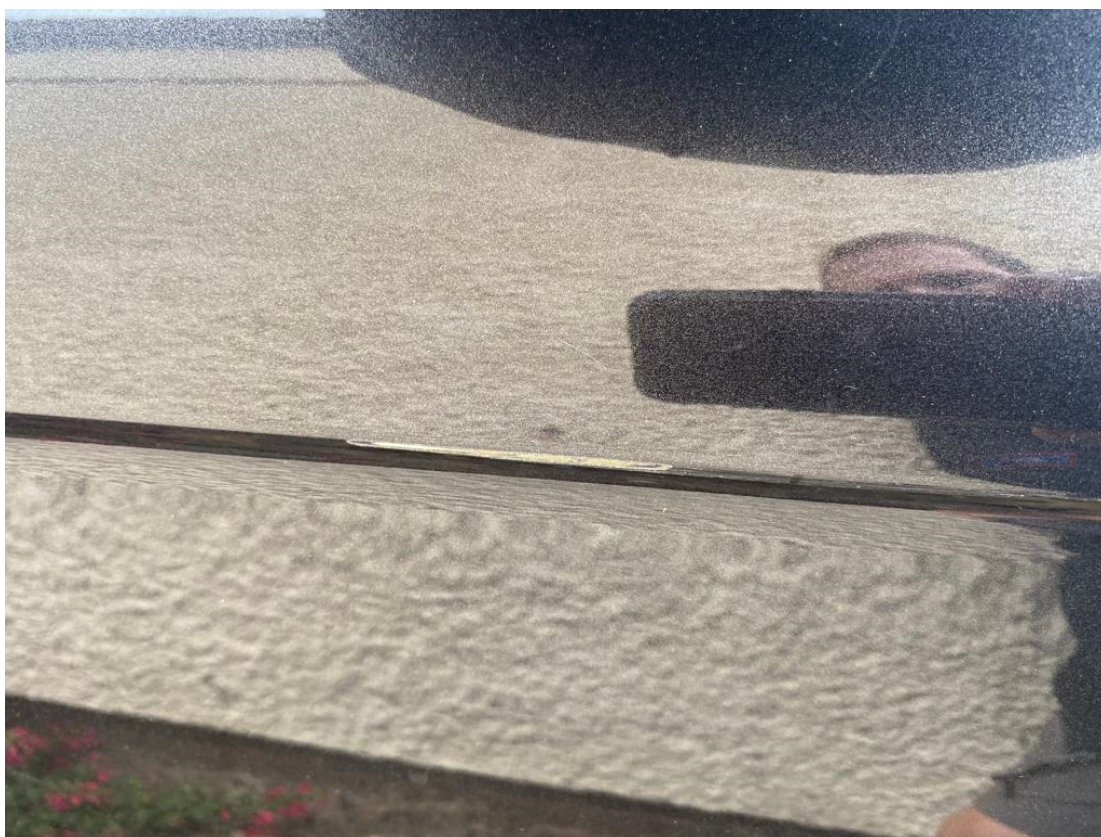
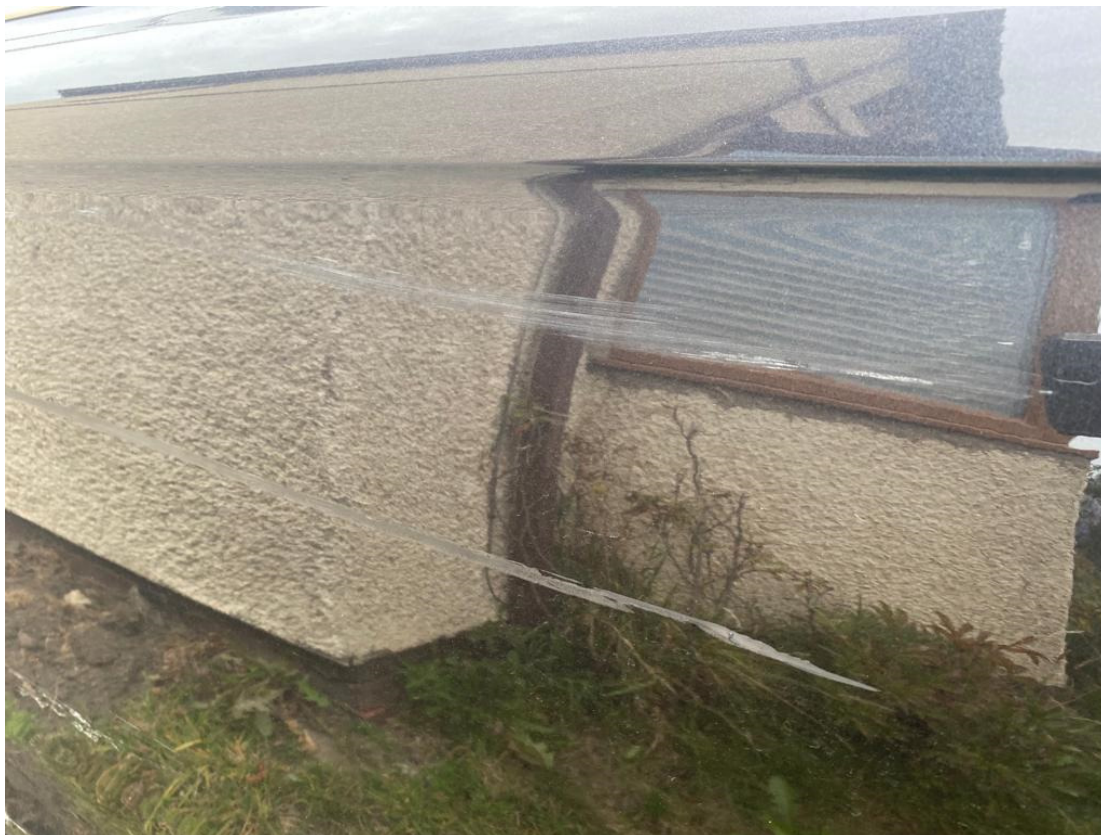
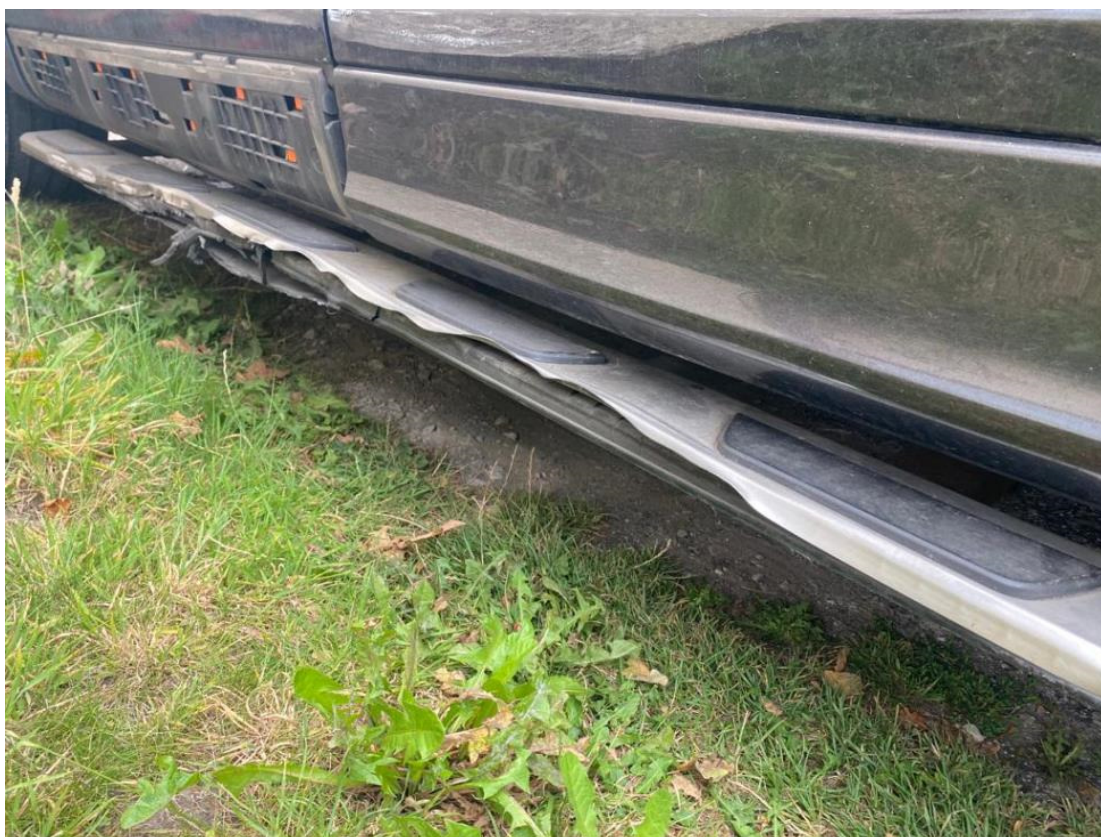
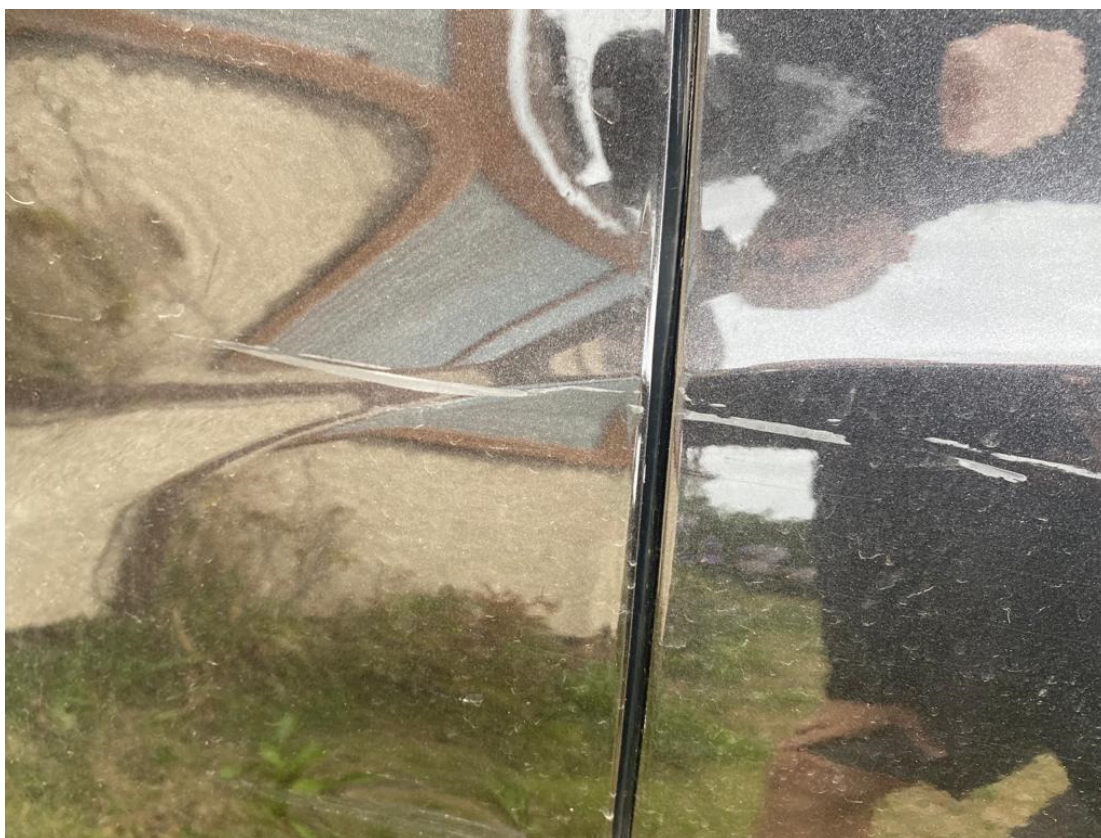
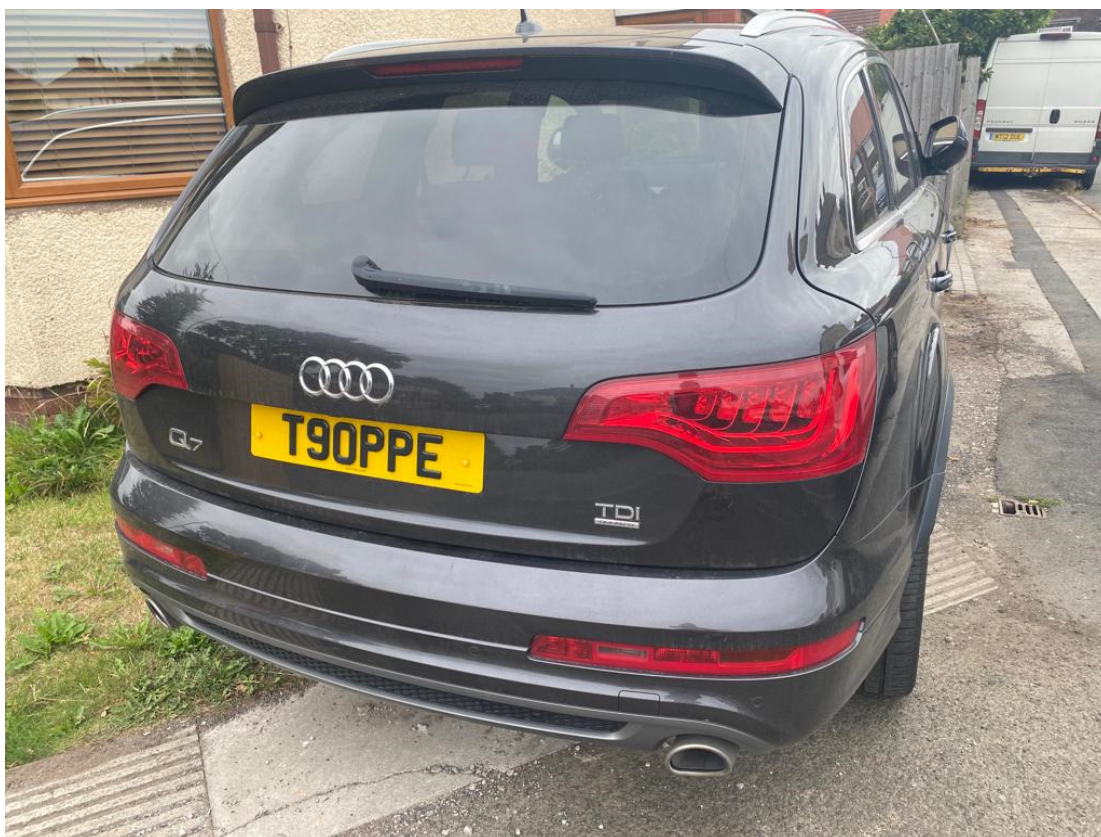
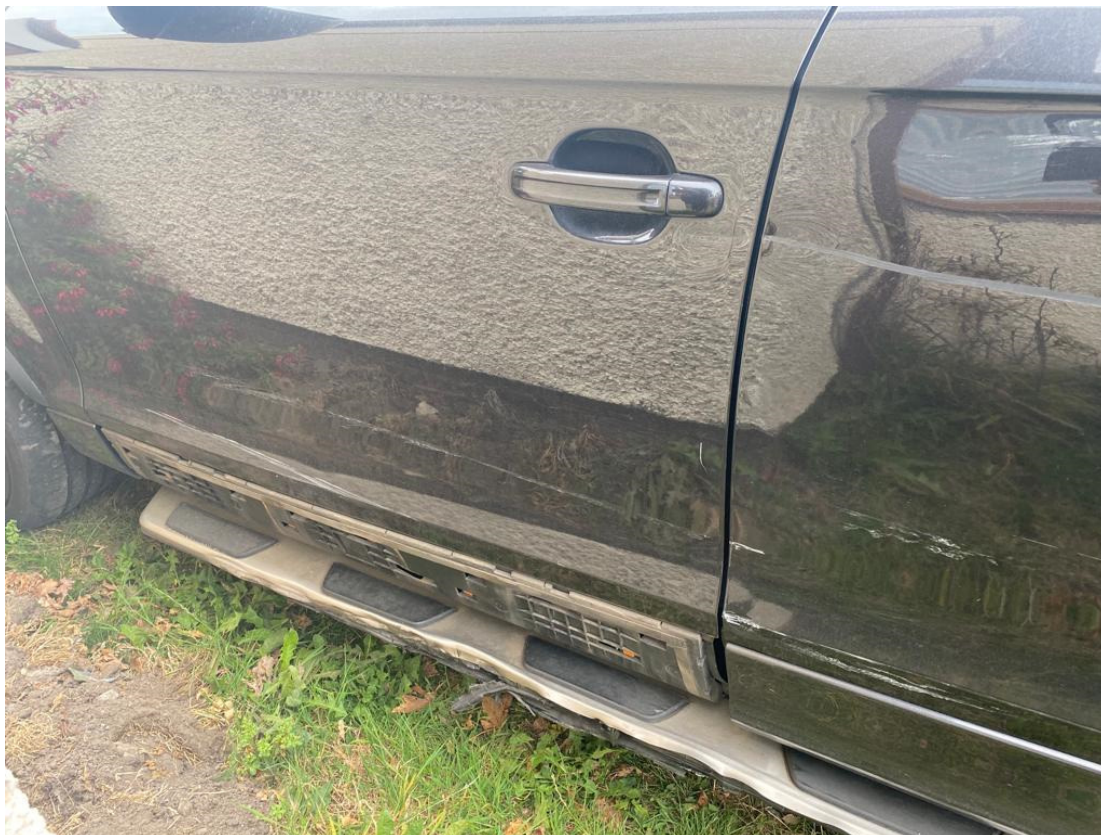
Please note the vehicle is unroadworthy due to the damaged nearside step.

| L/Wing Badge<br>L/F Door Handle<br>L/R Door<br>L/R Door Insulation<br>L/R Door Trim Front<br>L/R Door Lower Cover<br>L/R Door Insulation<br>L/R Outer Sill Mldg<br>L/R Bumper Guide<br>L/R Extension Rear<br>Sundry Parts | L/F Extension Rear<br>L/F Door Cover<br>L/R Outer Door Seal<br>L/R Door Clamp Kit<br>L/R Door Trim Rear<br>L/R Door Prot Foil<br>L/F Outer Sill Mldg<br>L/Side Step<br>L/R Extension Front<br>Car Care Kit |

| Left Front Door<br>L/R Side Panel | Rear Bumper |
