## To the Court REPAIRABLE REPORT

| Vehicle: <b>RENAULT CLIO ESPRIT ALPINE ETECH</b> | | Colour: <b>BLACK</b> | Speedo: <b>10946</b> Miles | |
| Reg No: <b>BG25DDL</b> | Registered: <b>Mar 2025</b> | Type: <b>5 Door Hatchback</b> | Trans: <b>Automatic</b> | |
| Damage: <b>Light Collision/Impact LH Side Mirror</b> | Incident: <b>25/03/2026</b> | L/H/F Tyre <b>Not Kno</b> | L/H/R Tyre <b>Not Kno</b> | |

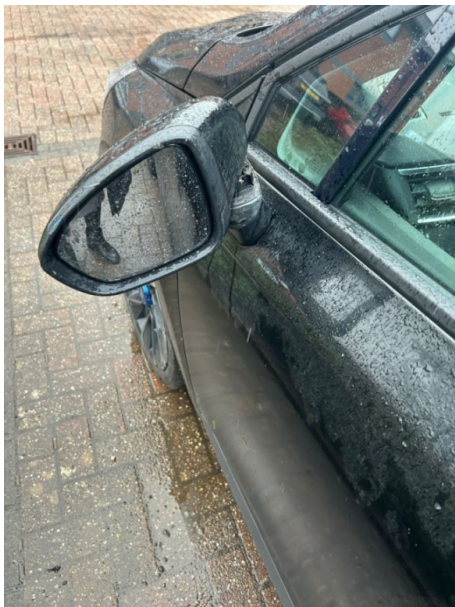
2\_Wingmirrordamage-V1.jpg

The vehicle has suffered light collision/impact damage to the left hand side mirror.

In our opinion this vehicle was not roadworthy at the time of our inspection as a result of the damage sustained due to NSF mirror damaged.

**New parts required:-** L/Door Mirror, L/Door Mirror Cover, L/Lower Mirror Cover, Panel Sundries, Car Care Kit, Glass Lifting Tape, Sundry Parts
