## To the Court REPAIRABLE REPORT

| Vehicle: <b>JEEP AVENGER SUMMIT EV</b> | | Colour: <b>GREY</b> | Speedo: <span style="border: 1px solid black; padding: 2px;">Miles</span> | |
| Reg No: <b>GL74UAN</b> | Registered: <b>Jan 2025</b> | Type: <b>5 Door Hatchback</b> | Trans: <b>Automatic</b> | |
| Damage: <b>Moderate Collision/Impact RH Rear</b> | Incident: <b>28/04/2026</b> | L/H/F Tyre <b>Not Kno</b> | L/H/R Tyre <b>Not Kno</b> | |

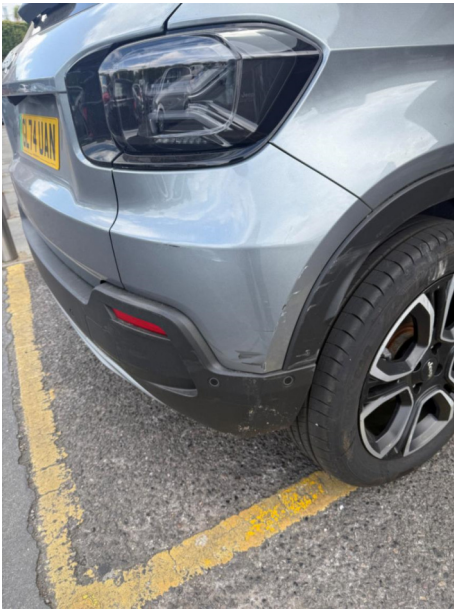
Imageofclientdamagejpg-V1.jpg

The vehicle has suffered moderate collision/impact damage to the right hand rear.

**New parts required:-**R/R Wheelarch Mldg, R/R Tyre, R/R Tyre Press Valve, Panel Sundries, Car Care Kit, Sundry Parts

**Repairable parts:-**Rear Upper Bumper
