26-1783818/2335766

# Total Loss Damage Assessment Report

| Model | Focus Zetec Tdci |
| Registration | YJ15POG |

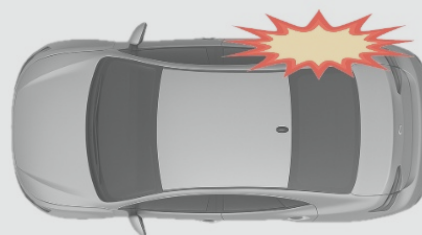
**Impact Diagram**

| Impact Magnitude | Moderate |

Vehicle will require a geometry check

Door Bar Damage - Door may not act appropriately under a secondary impact

Tyre requires replacement

Having examined the damage as presented, we have estimated repair times and methods, which are detailed below. We would recommend the vehicle to be dealt with on a total loss basis. The damage sustained to the vehicle would render the salvage as category 'S' (structural total loss) in accordance with the Salvage Code Of Practice.
