### **TOTAL LOSS REPORT**

**RE: Road traffic Accident: Ms Ailsa Milton: 21/03/2026**

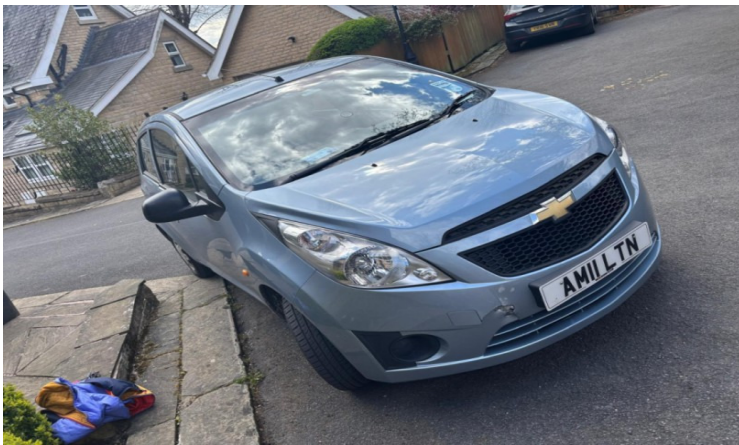
Impact Area

The vehicle has suffered moderate collision/impact damage to the left hand side.

Prior to returning the vehicle to use, we would advise a wheel alignment check is carried out.

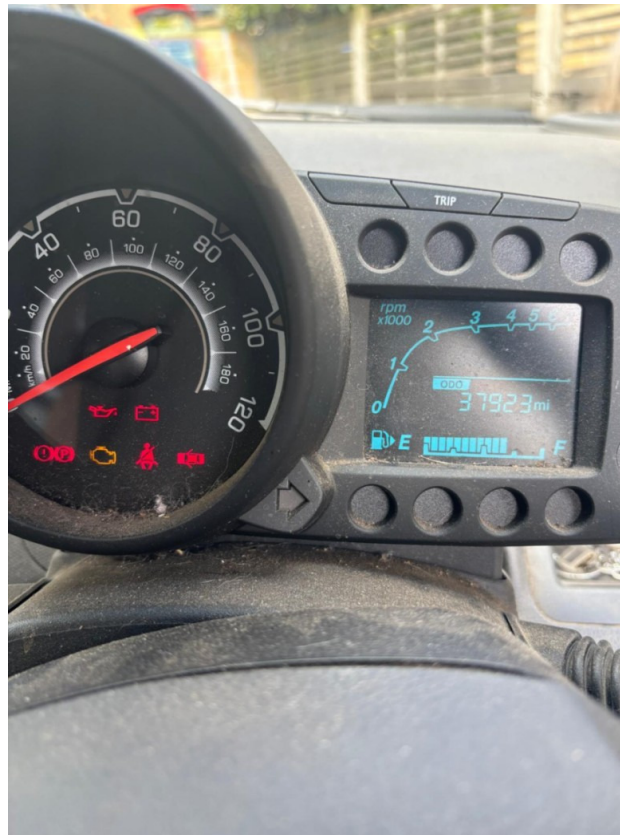
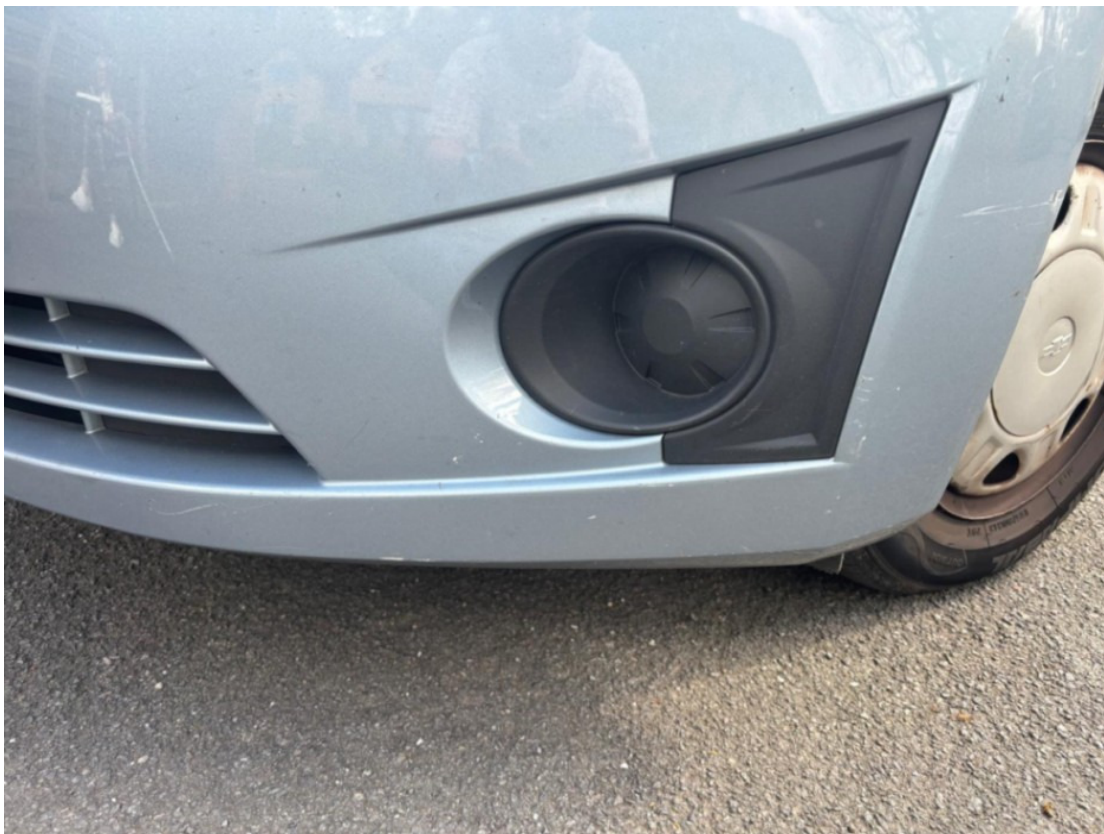
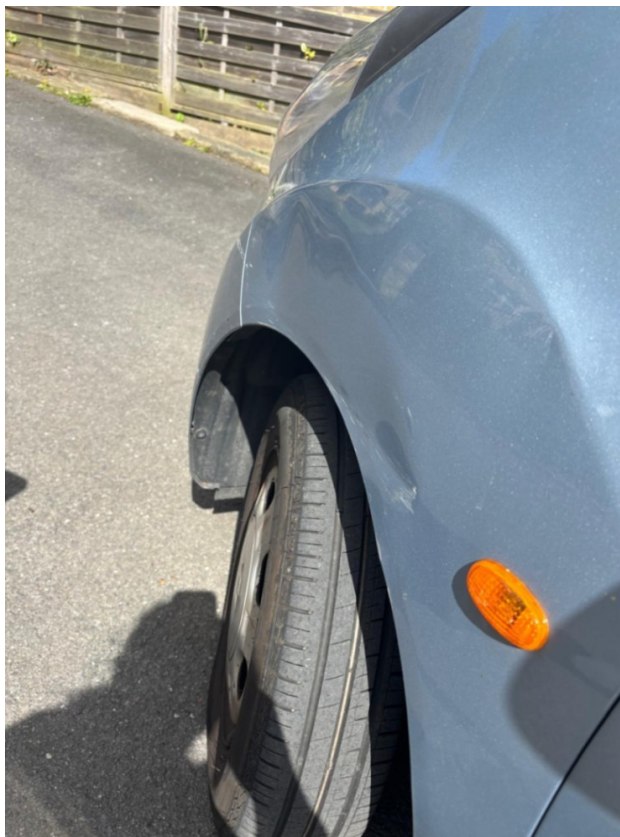
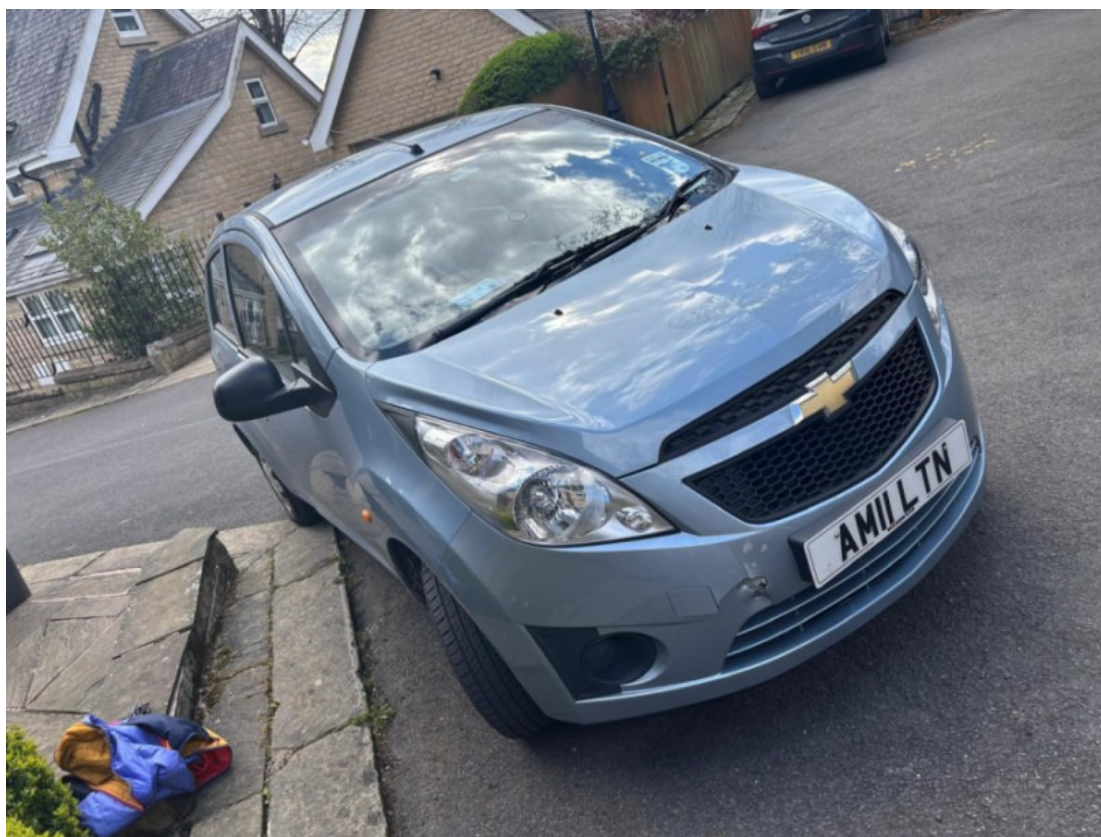
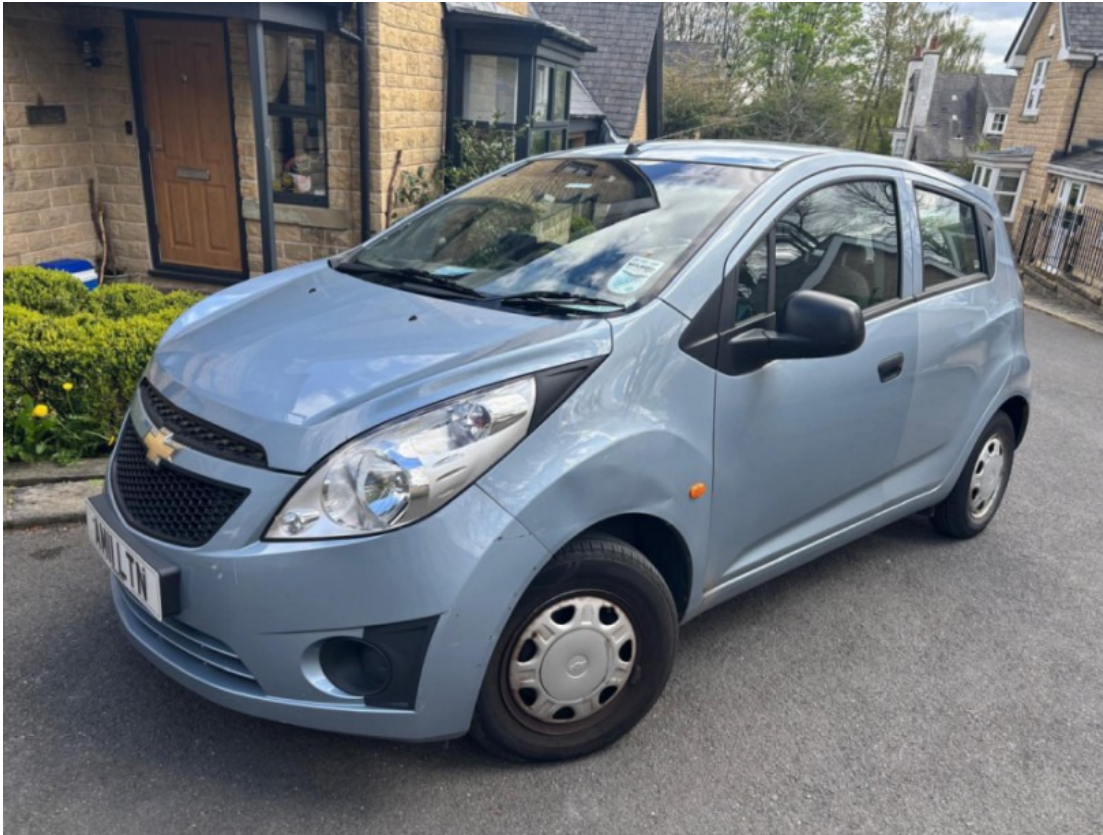
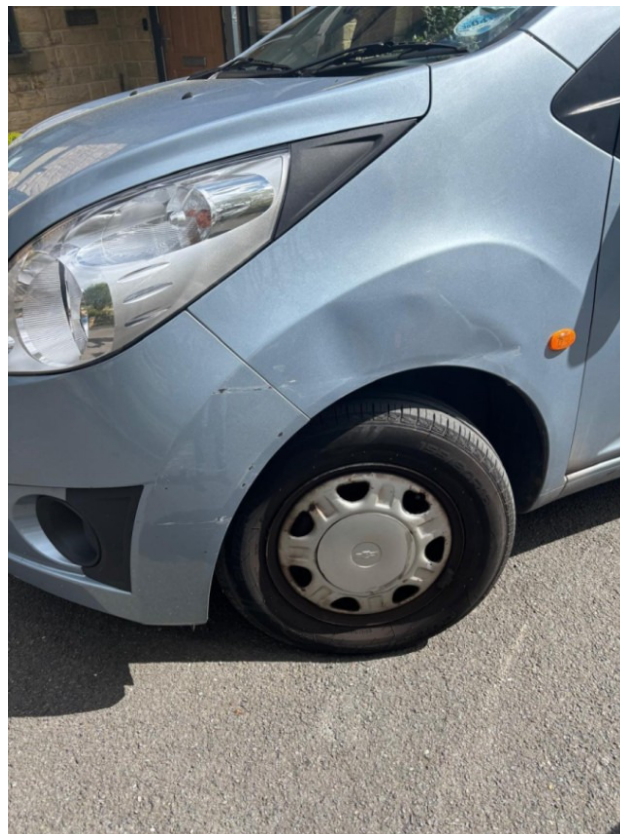
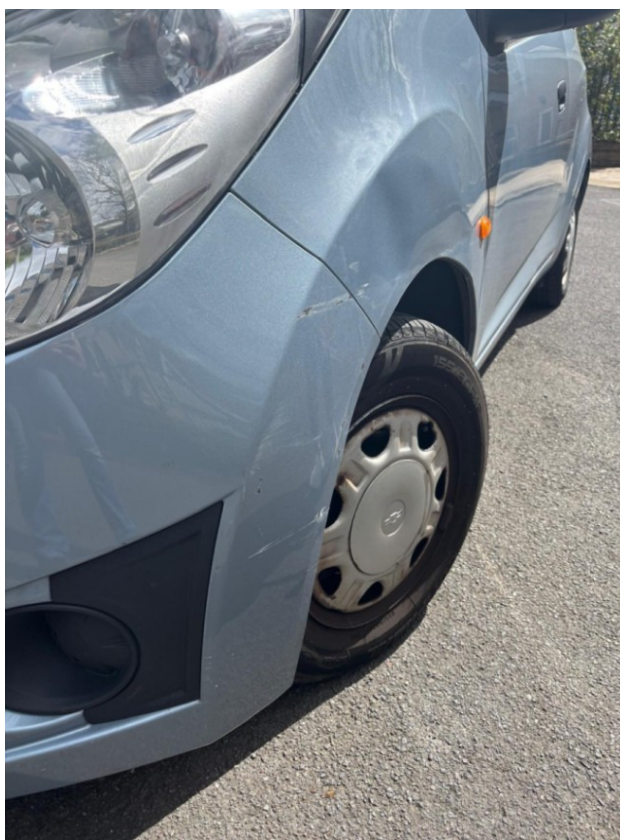
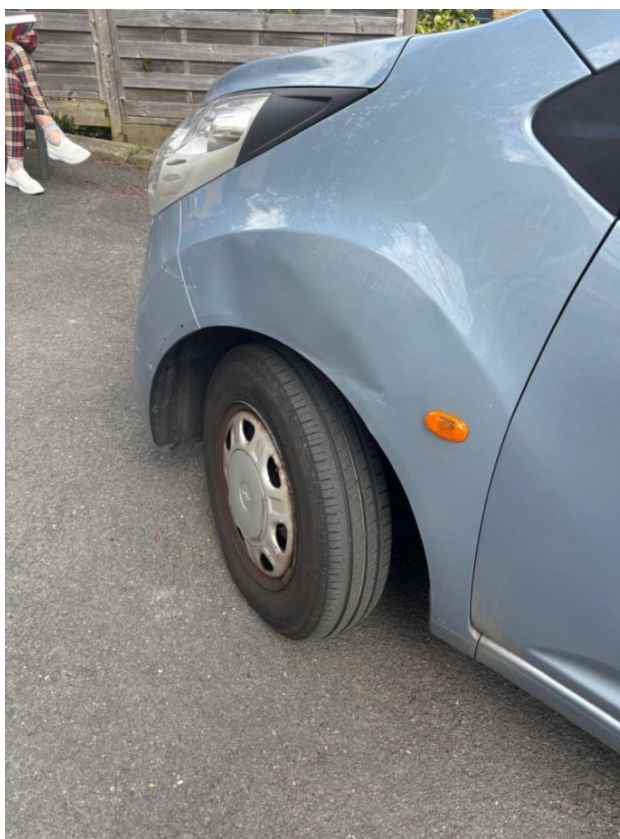
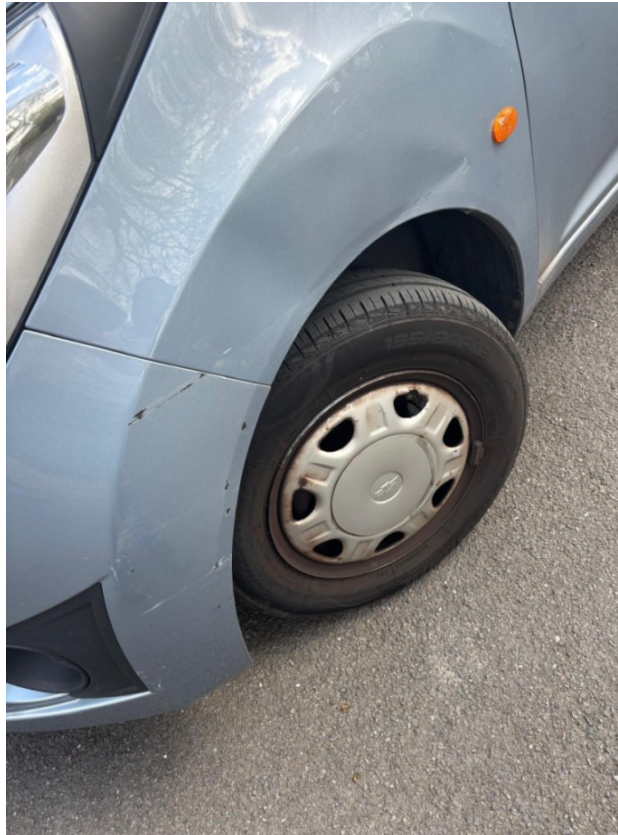
Left Front Wing  
Left Front Wing Liner  
Left Front Door Membrane

Left Front Wing Repair Kit  
Left Front Wing Panel Screw

#### Repairs required

Front Bumper Lining
