**Our Ref:** htu26022

**TOTAL LOSS REPORT**

**RE: Road traffic Accident: Sabaal Ahmed: 06/06/2026**

| Model | <b>PASSAT HIGHLINE TDI</b> | Status | <b>T/Loss</b> |

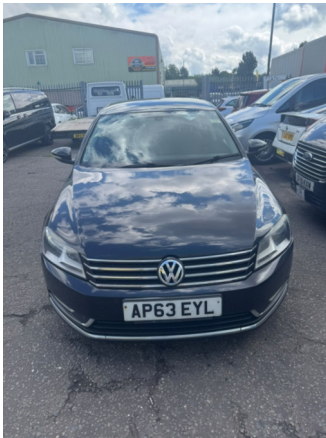
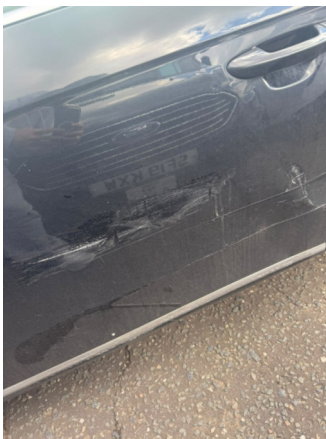
Impact Area

The vehicle has suffered light to moderate collision/impact damage to the left hand side.

Left Front Door Shell  
Left Front Door Lower Cover  
Left Front Door Outer Handle Seal  
Left Front Door Insulation

Left Rear Door Shell
