### **TOTAL LOSS REPORT**

**RE: Road traffic Accident: Miss Nathania Lauder: 26/07/2025**

**Our Ref:** qdos251150

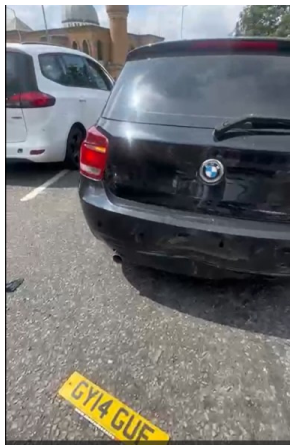
Impact Area

The vehicle has suffered moderate collision/impact damage to the rear.

31/07/2025 - Please note the vehicle is unroadworthy as the rear body has been compromised.
